Submitted by  
AECOM  
13640 Briarwick Drive  
Austin, Texas 78729  
October 13, 2023

# CCR Annual Inspection §257.83 (b)

Ash Pond

## A.B. Brown Generating Station

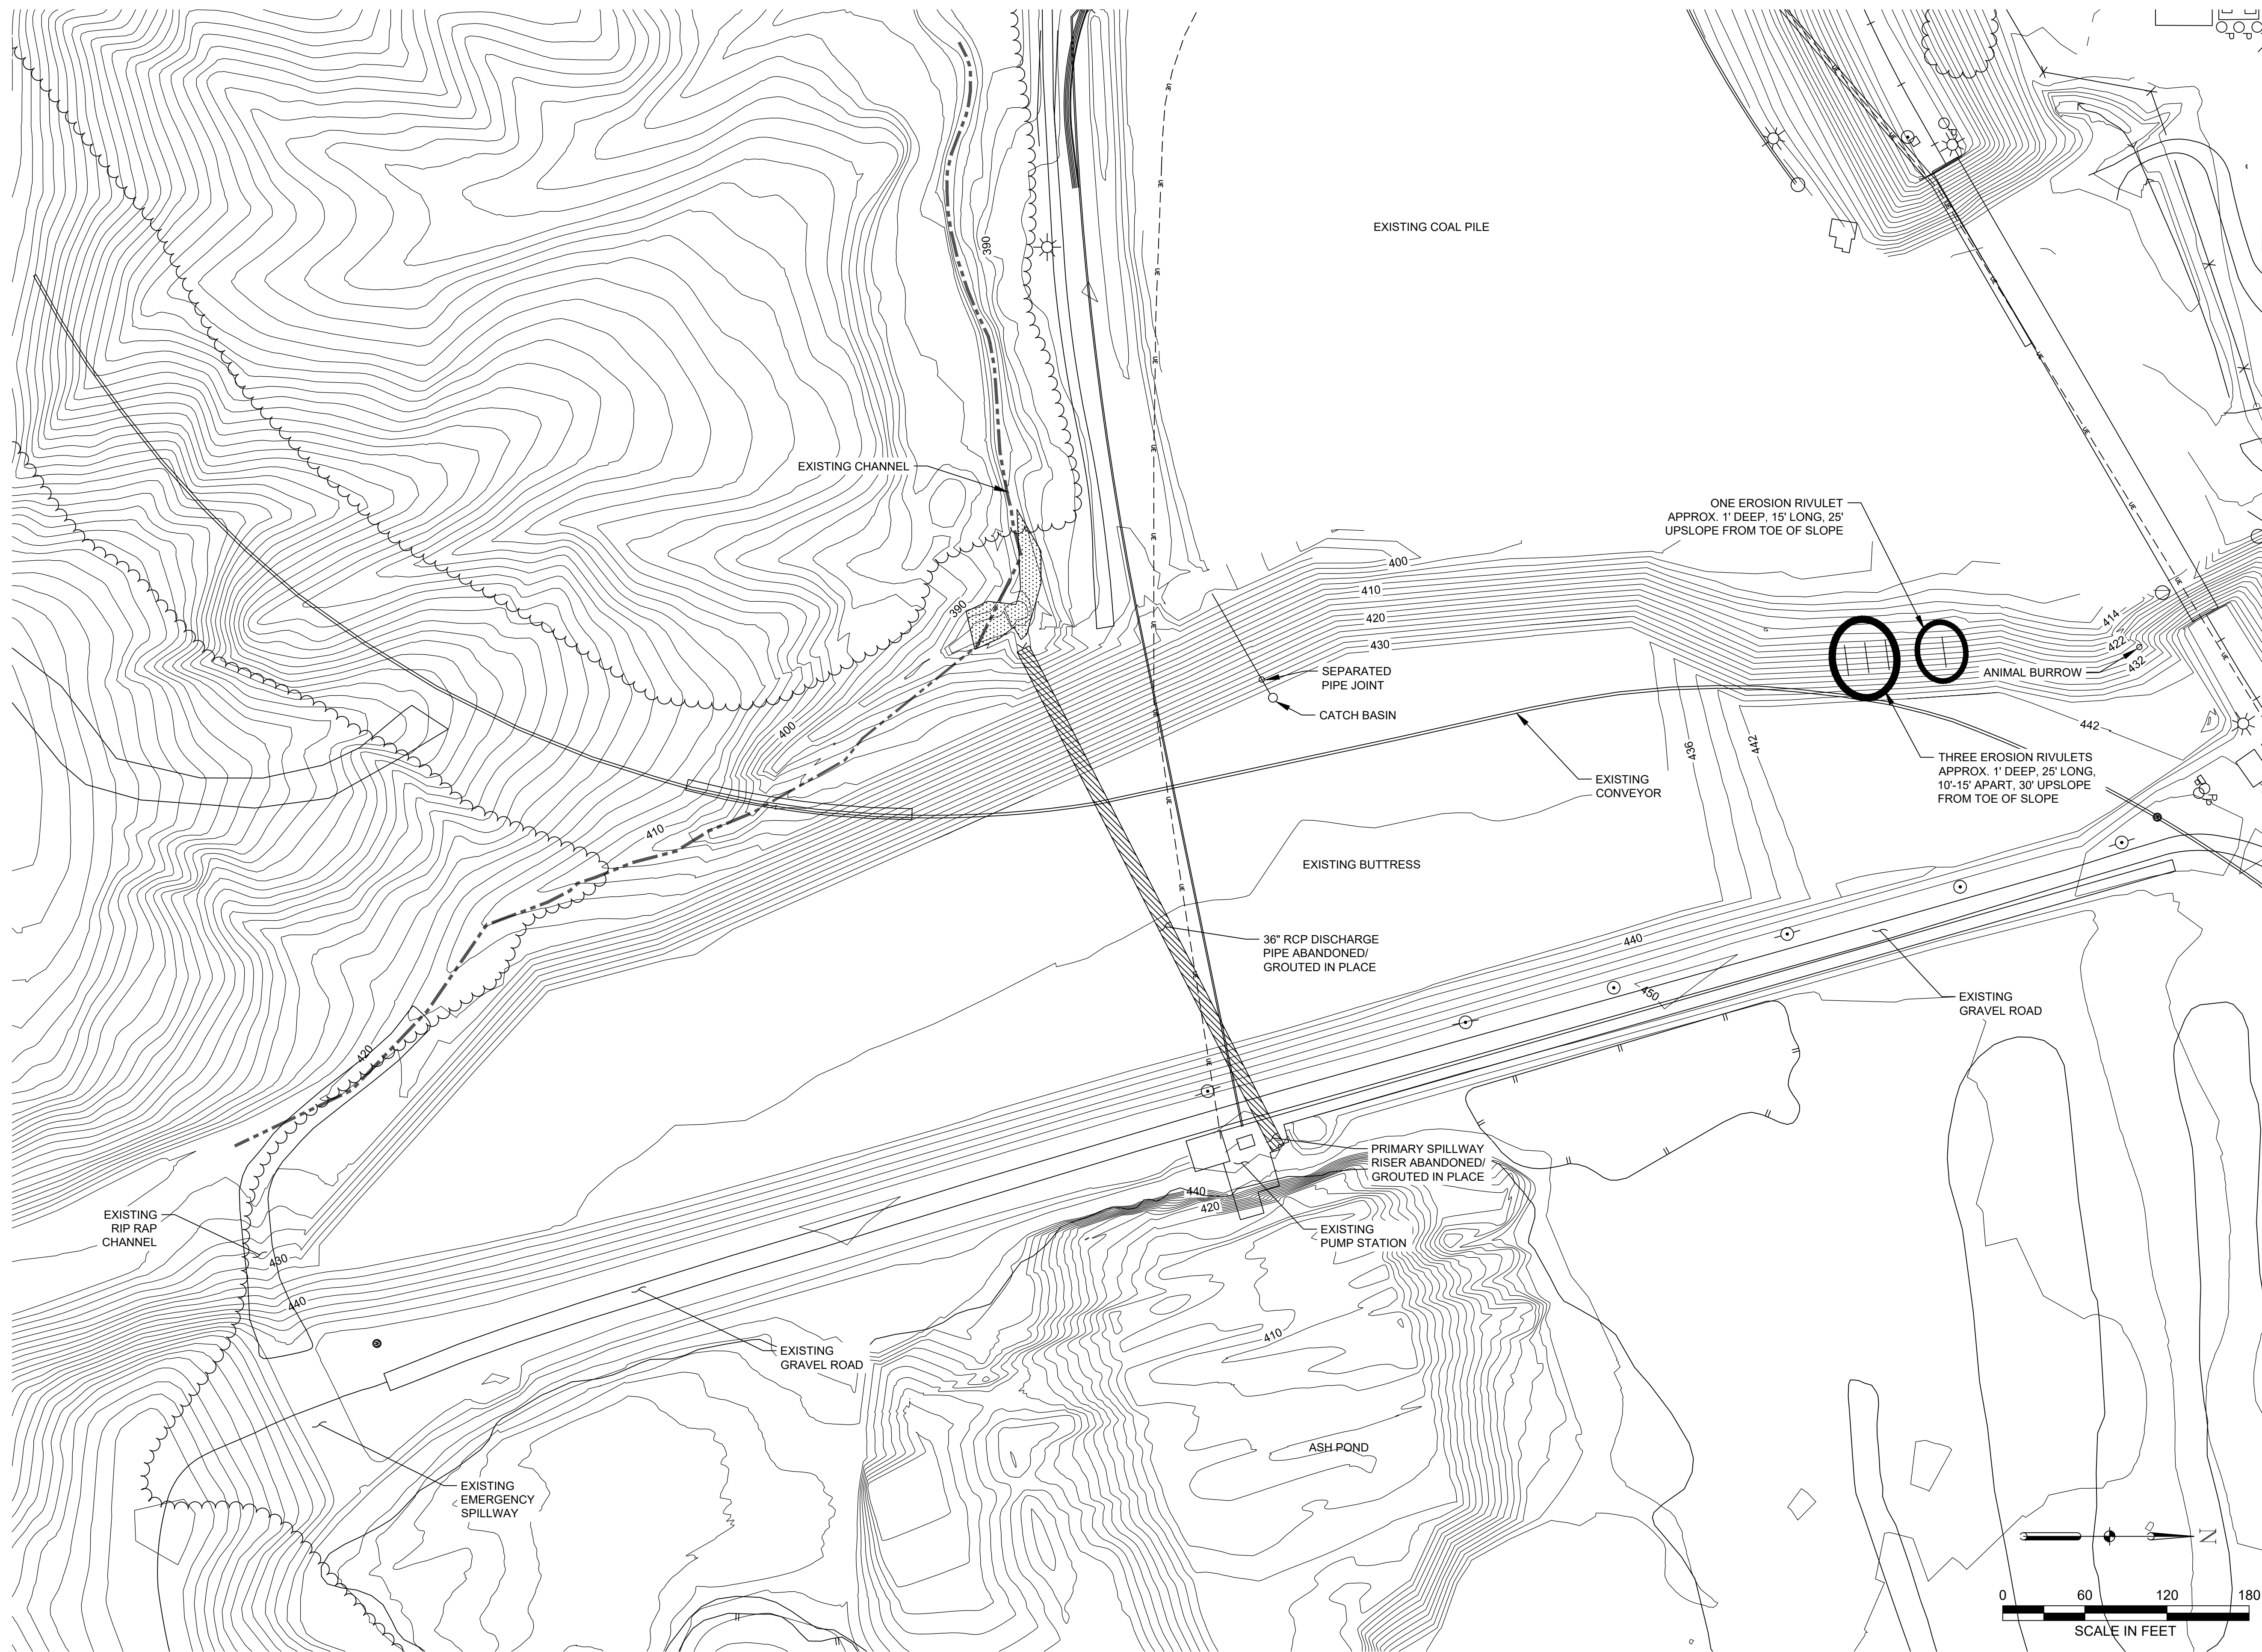
**FIGURE 3**

Table 2-3 – Areas of Concern (Inspected: September 25, 2023)	
Deficiency/Observation	Proposed Corrective Measure
Three erosion rivulets approximately 12" deep, 25' long, 10' - 15' apart, approximately 30' upslope from the northern toe of buttress slope were identified adjacent to each other. See Figure 3.	Erosion rivulets to be filled, regraded and seeded/mulched.
One erosion rivulet approximately 12" deep, 15' long, approximately 30' upslope from the northern toe of buttress slope were identified adjacent to each other. See Figure 3.	Erosion rivulets to be filled, regraded and seeded/mulched.
One approximately 8" diameter animal burrow approximately mid-slope, adjacent to right abutment. See Figure 3.	Hole to be filled with soil then compacted and seeded/mulched.
One stormwater catch basin discharge pipe subsurface pipe joint separation. See Figure 3.	Separated pipe joint to be exposed and new coupling added to join pipes. Backfill/compact with soil in work area, and seed and mulch.
