VISUAL SITE INSPECTION REPORT – 2019

**SOUTHERN INDIANA GAS AND ELECTRIC
A. B. BROWN GENERATING STATION
TYPE III RESTRICTED WASTE LANDFILL
WEST FRANKLIN, IN**

ATC PROJECT NO. 170LF00789

January 7, 2020

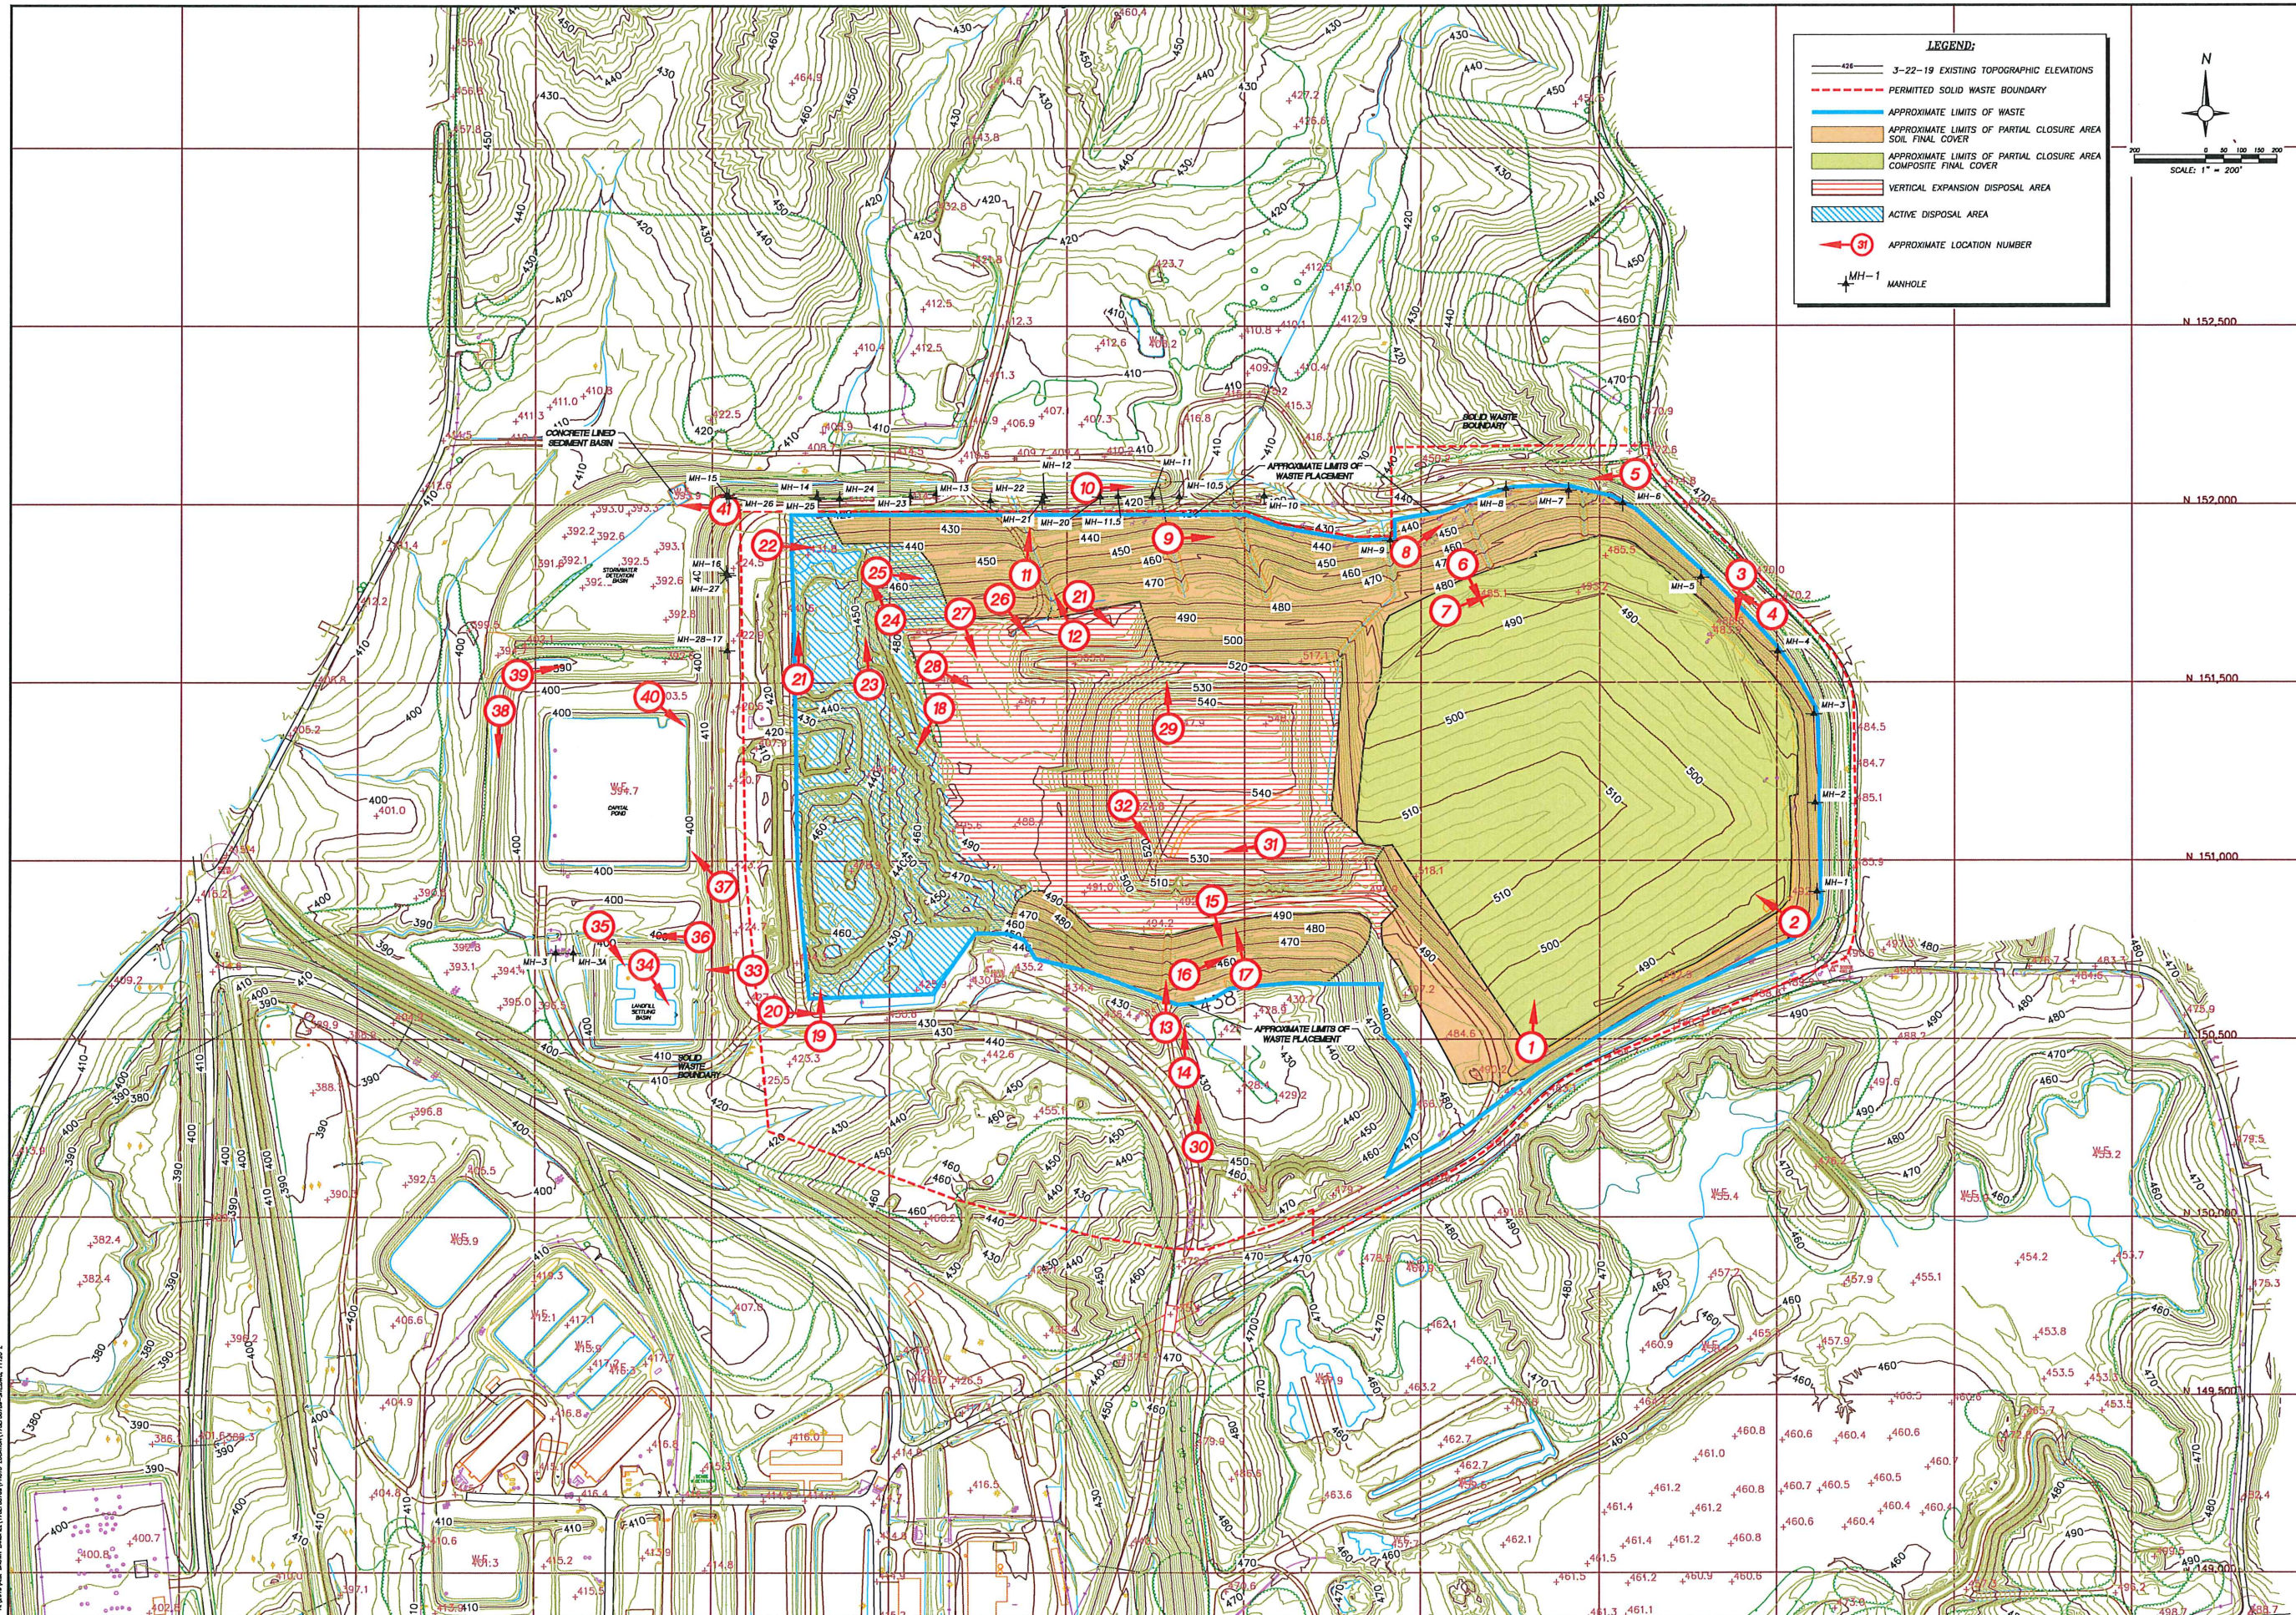
Drawing Title:
 SITE PLAN
 TYPE III RWS LANDFILL
 8511 WELBORN ROAD
 MOUNT VERNON, INDIANA 47620

The approximate limits of each of these areas is noted on Sheet 1 in Appendix A. The following paragraphs include a summary of the observations made during the inspection followed by our recommendations in bold print. Approximate locations of some of the observed features are noted on Sheet 1 in Appendix A.

- 4) On the north side of the Composite Final Cover Area, one of the four drop inlets present has become clogged with vegetation debris (Locations 6 and 7).

- 6) Observations made during the site visit indicate that Manholes 1 through 6, 8, 9, 10.5, 11, 11.5, 12, 20 and 21 are flowing without significant obstruction. Based on water levels noted in Manholes 7 and 10, some blockage appeared to be present at those locations at the time of the inspection. Maintenance was being performed to remove the blockage from Manhole 10 at the time of the inspection (Location 9).

- 8) The inspection noted filter cake in the drainage ditch north of the north slope of the landfill outside of the Solid Waste Boundary (Location 10). At the time of this inspection, there was no evidence to indicate migration of waste beyond the property boundary.

- 9) The riprap in a downchute near the west end of the north slope has been displaced at several locations, including one area where the geotextile underlying the riprap is now exposed (Location 11). A significant amount of soil sediment was also noted in the riprap (Location 12) and in the drainage ditch that receives discharge from that downchute. Site personnel indicated that the displacement of the riprap and deposition of the soil sediment occurred as the result of a recent significant rain event. Based on field observations, it appears that the drainage area that is now discharging to this downchute increased significantly as a result of the 2019 filling operations in the vertical expansion area. It appears that this downchute was not designed to accommodate this additional discharge.

- 11) The inlet of one of the downdrain pipes, which conveys water from one of the drainage terraces on the south slope is partially clogged (Location 15). Further, a subsidence feature was noted along the pipe alignment (Location 16) and the pipe has been damaged near its outlet (Location 17).

- 2) There is a limited amount of freeboard between the surface of the waste and the adjoining access road at the south end of the Active Landfill Area (Location 20). In addition, surface water runoff from the northern portion of the Active Landfill Area is routed to a depression with limited freeboard at the far north end (Locations 21 and 22).

- 3) Filter cake has recently been stockpiled at the north end of the active fill area (Location 23). A portion of this stockpile extends onto the cover soils at the west end of the north side of the Landfill Partial Closure Area (Location 24) creating a potential path for filter cake to migrate on to the north slope of the partial closure area (Location 25).

- 2) The southeast portion of the pond has accumulated sediment that may impair the discharge into the pond (Location 34).

- 5) The inspection noted an accumulation of sediment in the northeast corner of the Capitol Pond (Location 40).

- 6) The concrete lined sediment basin located within the detention basin was nearly full of sediment at the time of this inspection (Location 41).

Recommendation: Remove debris to restore the original condition. This drop inlet was also noted to be clogged during the 2018 inspection. It is recommended that the drop inlet be inspected at least quarterly to remove accumulated debris.

Recommendation: Remove filter cake from the drainage ditch to help control the migration of filter cake outside of the Solid Waste Boundary and continue proactive maintenance of stormwater controls.

Recommendation: Re-establish the riprap protective layer in the downchute as soon as practical to try to avoid further damage to the downchute. An analysis should be performed to modify the temporary stormwater controls to either divert a portion of the

drainage area to a different outlet pipe or channel, or provide some detention to reduce the peak flow to the downchute.

Recommendation: The debris should be removed from the pipe inlet and the eroded area near the outlet should be revegetated. Further, the downdrain pipe should be repaired and the subsidence area backfilled.

Recommendation: Monitor these areas during significant storm events to avoid the release of filter cake. Consider regrading the areas to provide additional storage capacity for stormwater runoff and/or add a soil berm to increase freeboard in these areas.

Recommendation: Regrade the filter cake stockpile to ensure that all runoff from the pile is contained within the active fill area to prevent filter cake from migrating outside the Solid Waste Boundary.

Recommendation: Remove accumulated sediments as needed to maintain the pond capacity.

Recommendation: Remove the sediment from the basin and place it in the landfill.

Recommendation: Remove the sediment from the basin and place it in the landfill. Monitor the basin and remove sediment once the basin is approximately half full to help minimize the potential migration of filter cake into the detention basin.
