VISUAL SITE INSPECTION REPORT – 2021

SOUTHERN INDIANA GAS AND ELECTRIC
A.B. BROWN GENERATING STATION
TYPE III RESTRICTED WASTE LANDFILL
WEST FRANKLIN, IN

ATC PROJECT NO. 170LF01149

JANUARY 7, 2022

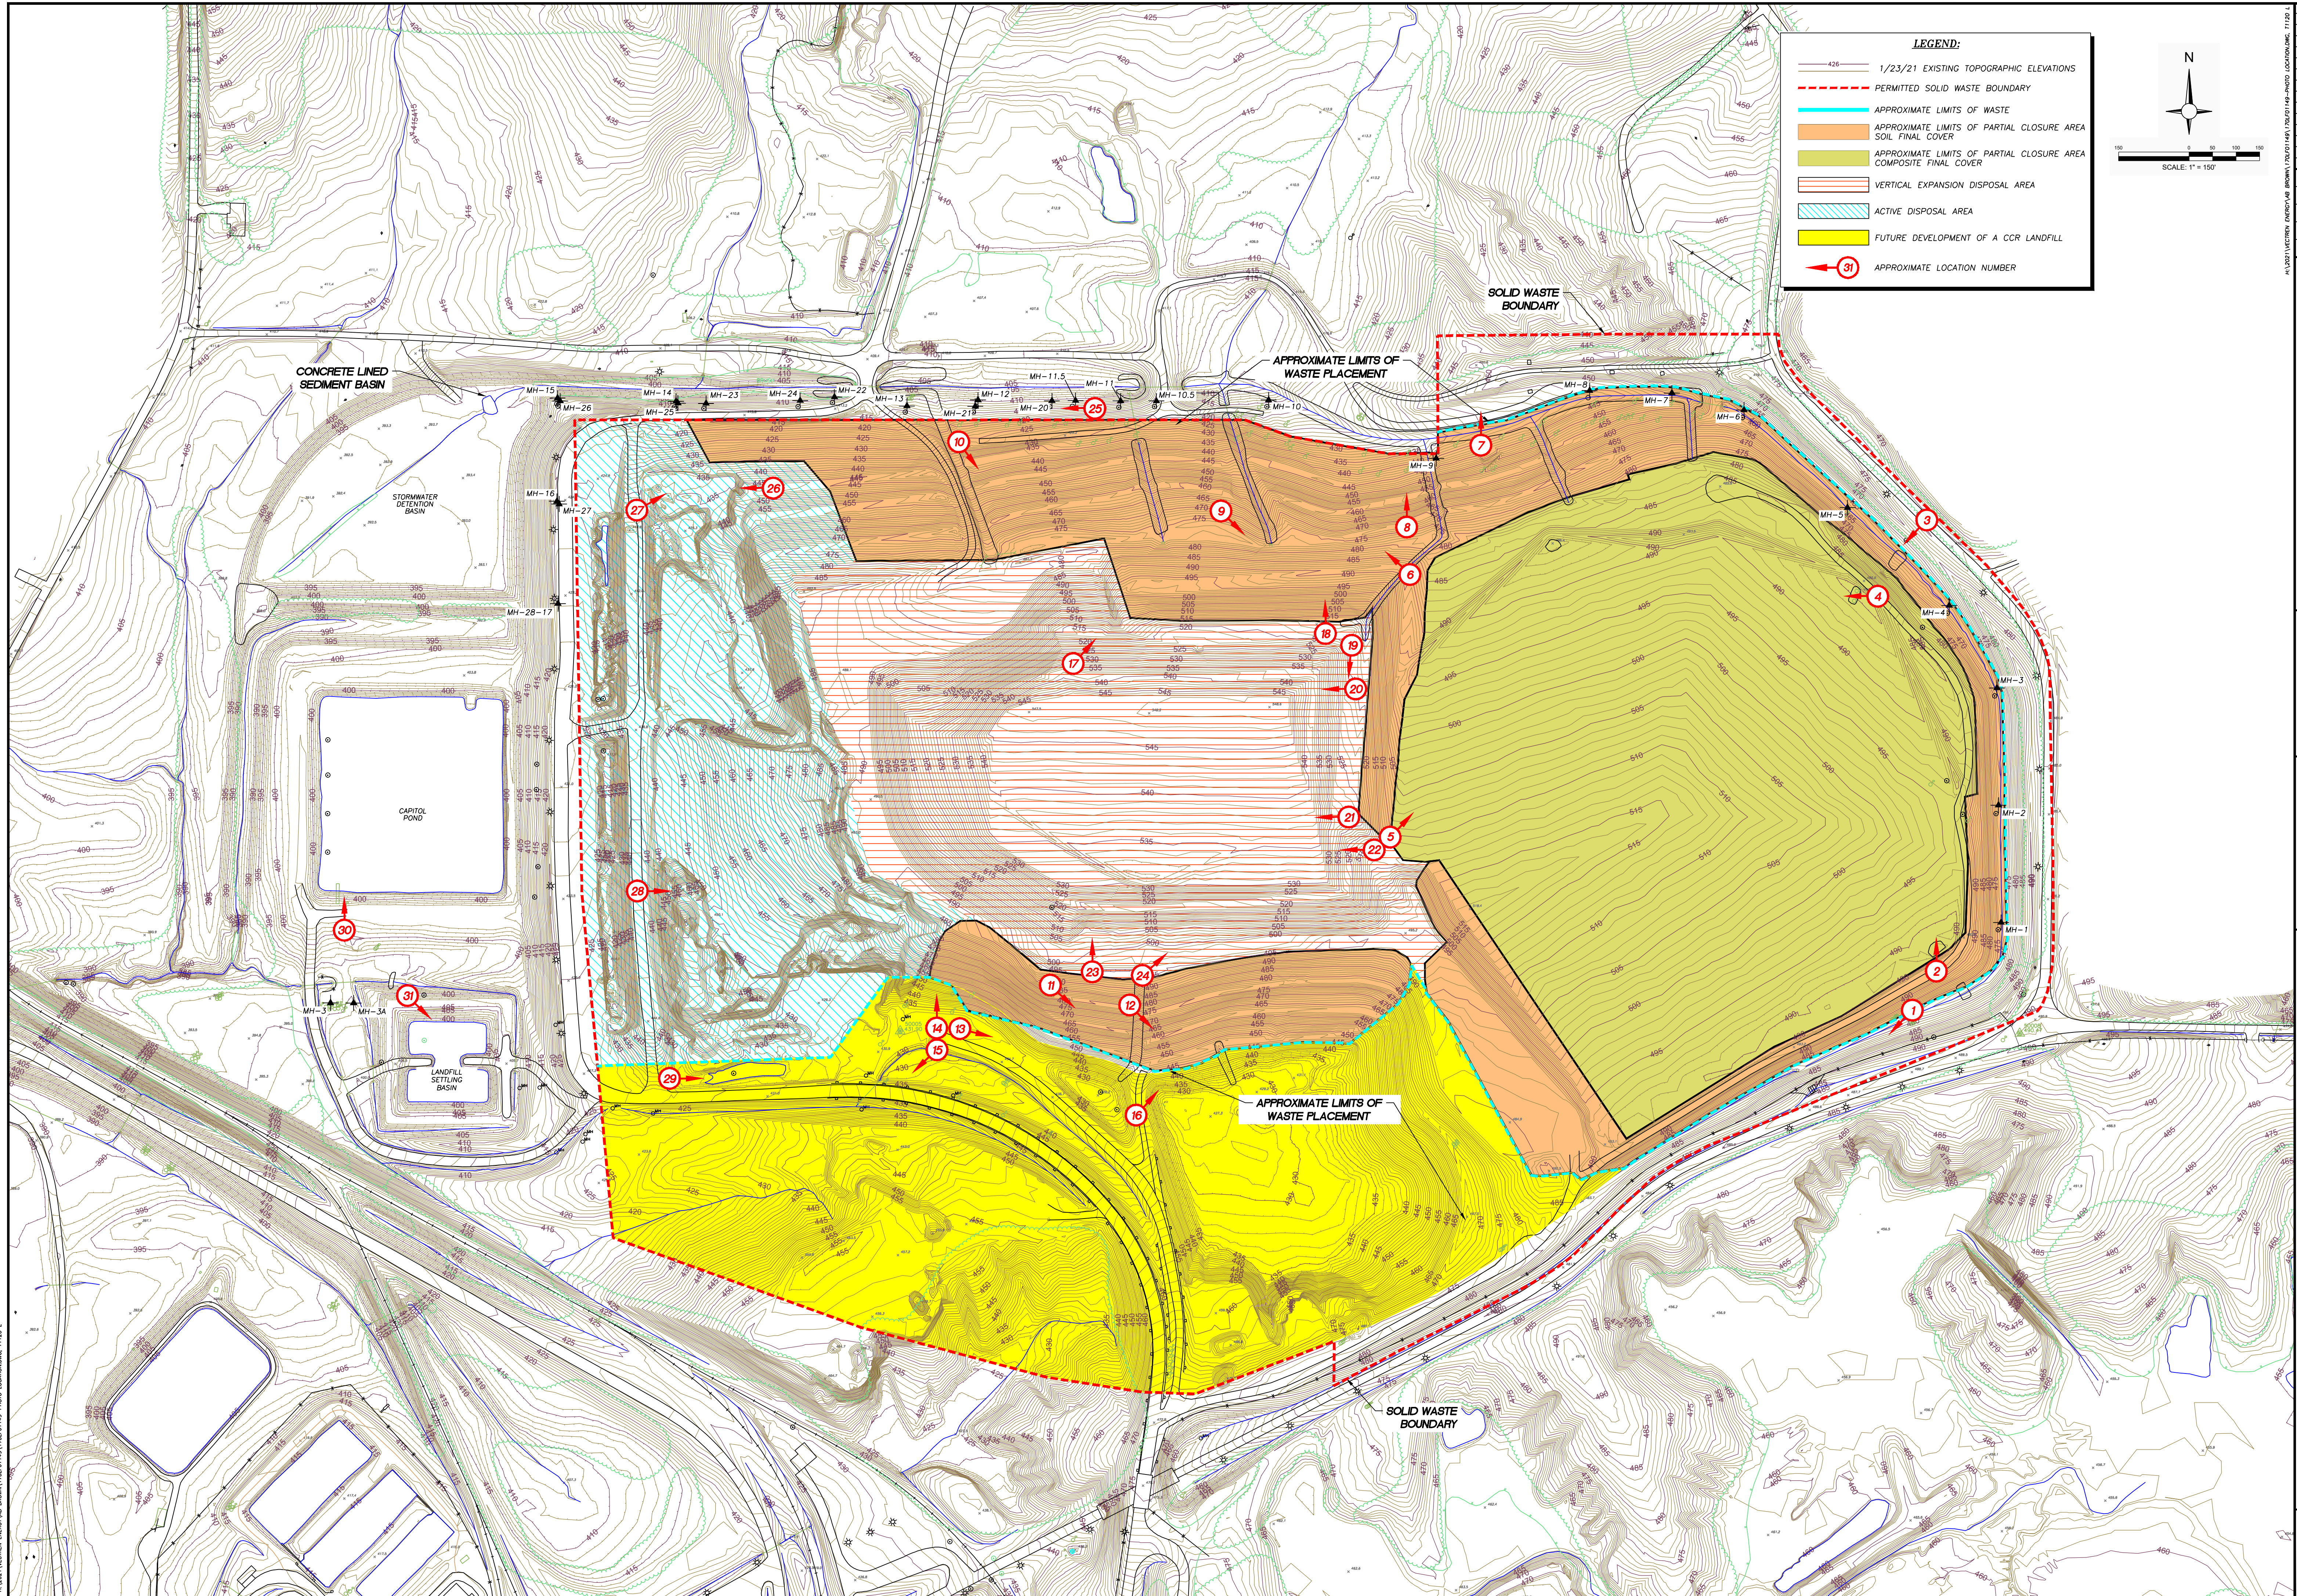
- 2) Observed sparse vegetation of the Final Cover (Locations 1, 5, 9, 11, 12, 13, 14, and 16).

- 2) Observed sparse vegetation around side slopes areas located on the north and east sides of the Vertical Expansion Disposal Area (Locations 17, 18, 19, 21, and 22).

- 3) Erosion at the outlet of a culvert and erosion rills have formed adjacent to a road on the south slope of the Vertical Expansion Disposal Area (Locations 23, and 24).

- 4) Observed filter cake in the bottom of Manhole No. 11.5 where a pipe from the Vertical Expansion Disposal Area discharges into the manhole. (Location 25).

- 2) There is a limited amount of freeboard between the surface of the waste and the adjoining access road at the south end of the Active Landfill Area (Location 29). In addition, surface water runoff from the northern portion of the Active Landfill Area is routed to a depression with at the far north end (Locations 27). It should be noted that the available freeboard at Location 27 has been improved compared to previous inspections.

- 2) Observed sparse vegetation adjacent to the access road to the Landfill Settling Basin (Locations 30).

Recommendation: Areas of sparse vegetation should be reseeded with similar grasses to the ones at the site, and temporarily isolated to prevent trampling and help re-establish grass cover.

Recommendation: Areas of sparse vegetation should be reseed with similar grasses to the ones at the site, and temporarily isolated to prevent trampling and help re-establish grass cover.

Recommendation: Install riprap or another form of armouring at the culvert outlet. Repair rills, install erosion control blankets and/or other erosion BMPs, and reseed areas to re-establish grass cover.

Recommendation: The erosion and sediment controls in the Vertical Expansion Disposal Area should be upgraded and additional sediment control protection should be installed at the pipe inlet.

Recommendation: Monitor these areas during and after significant storm events to maintain adequate freeboard.
