**VISUAL SITE INSPECTION REPORT – 2023**

SOUTHERN INDIANA GAS AND ELECTRIC  
A.B. BROWN GENERATING STATION  
TYPE III RESTRICTED WASTE LANDFILL  
WEST FRANKLIN, IN

ATLAS PROJECT NO. 170LF01572

JANUARY 3, 2024

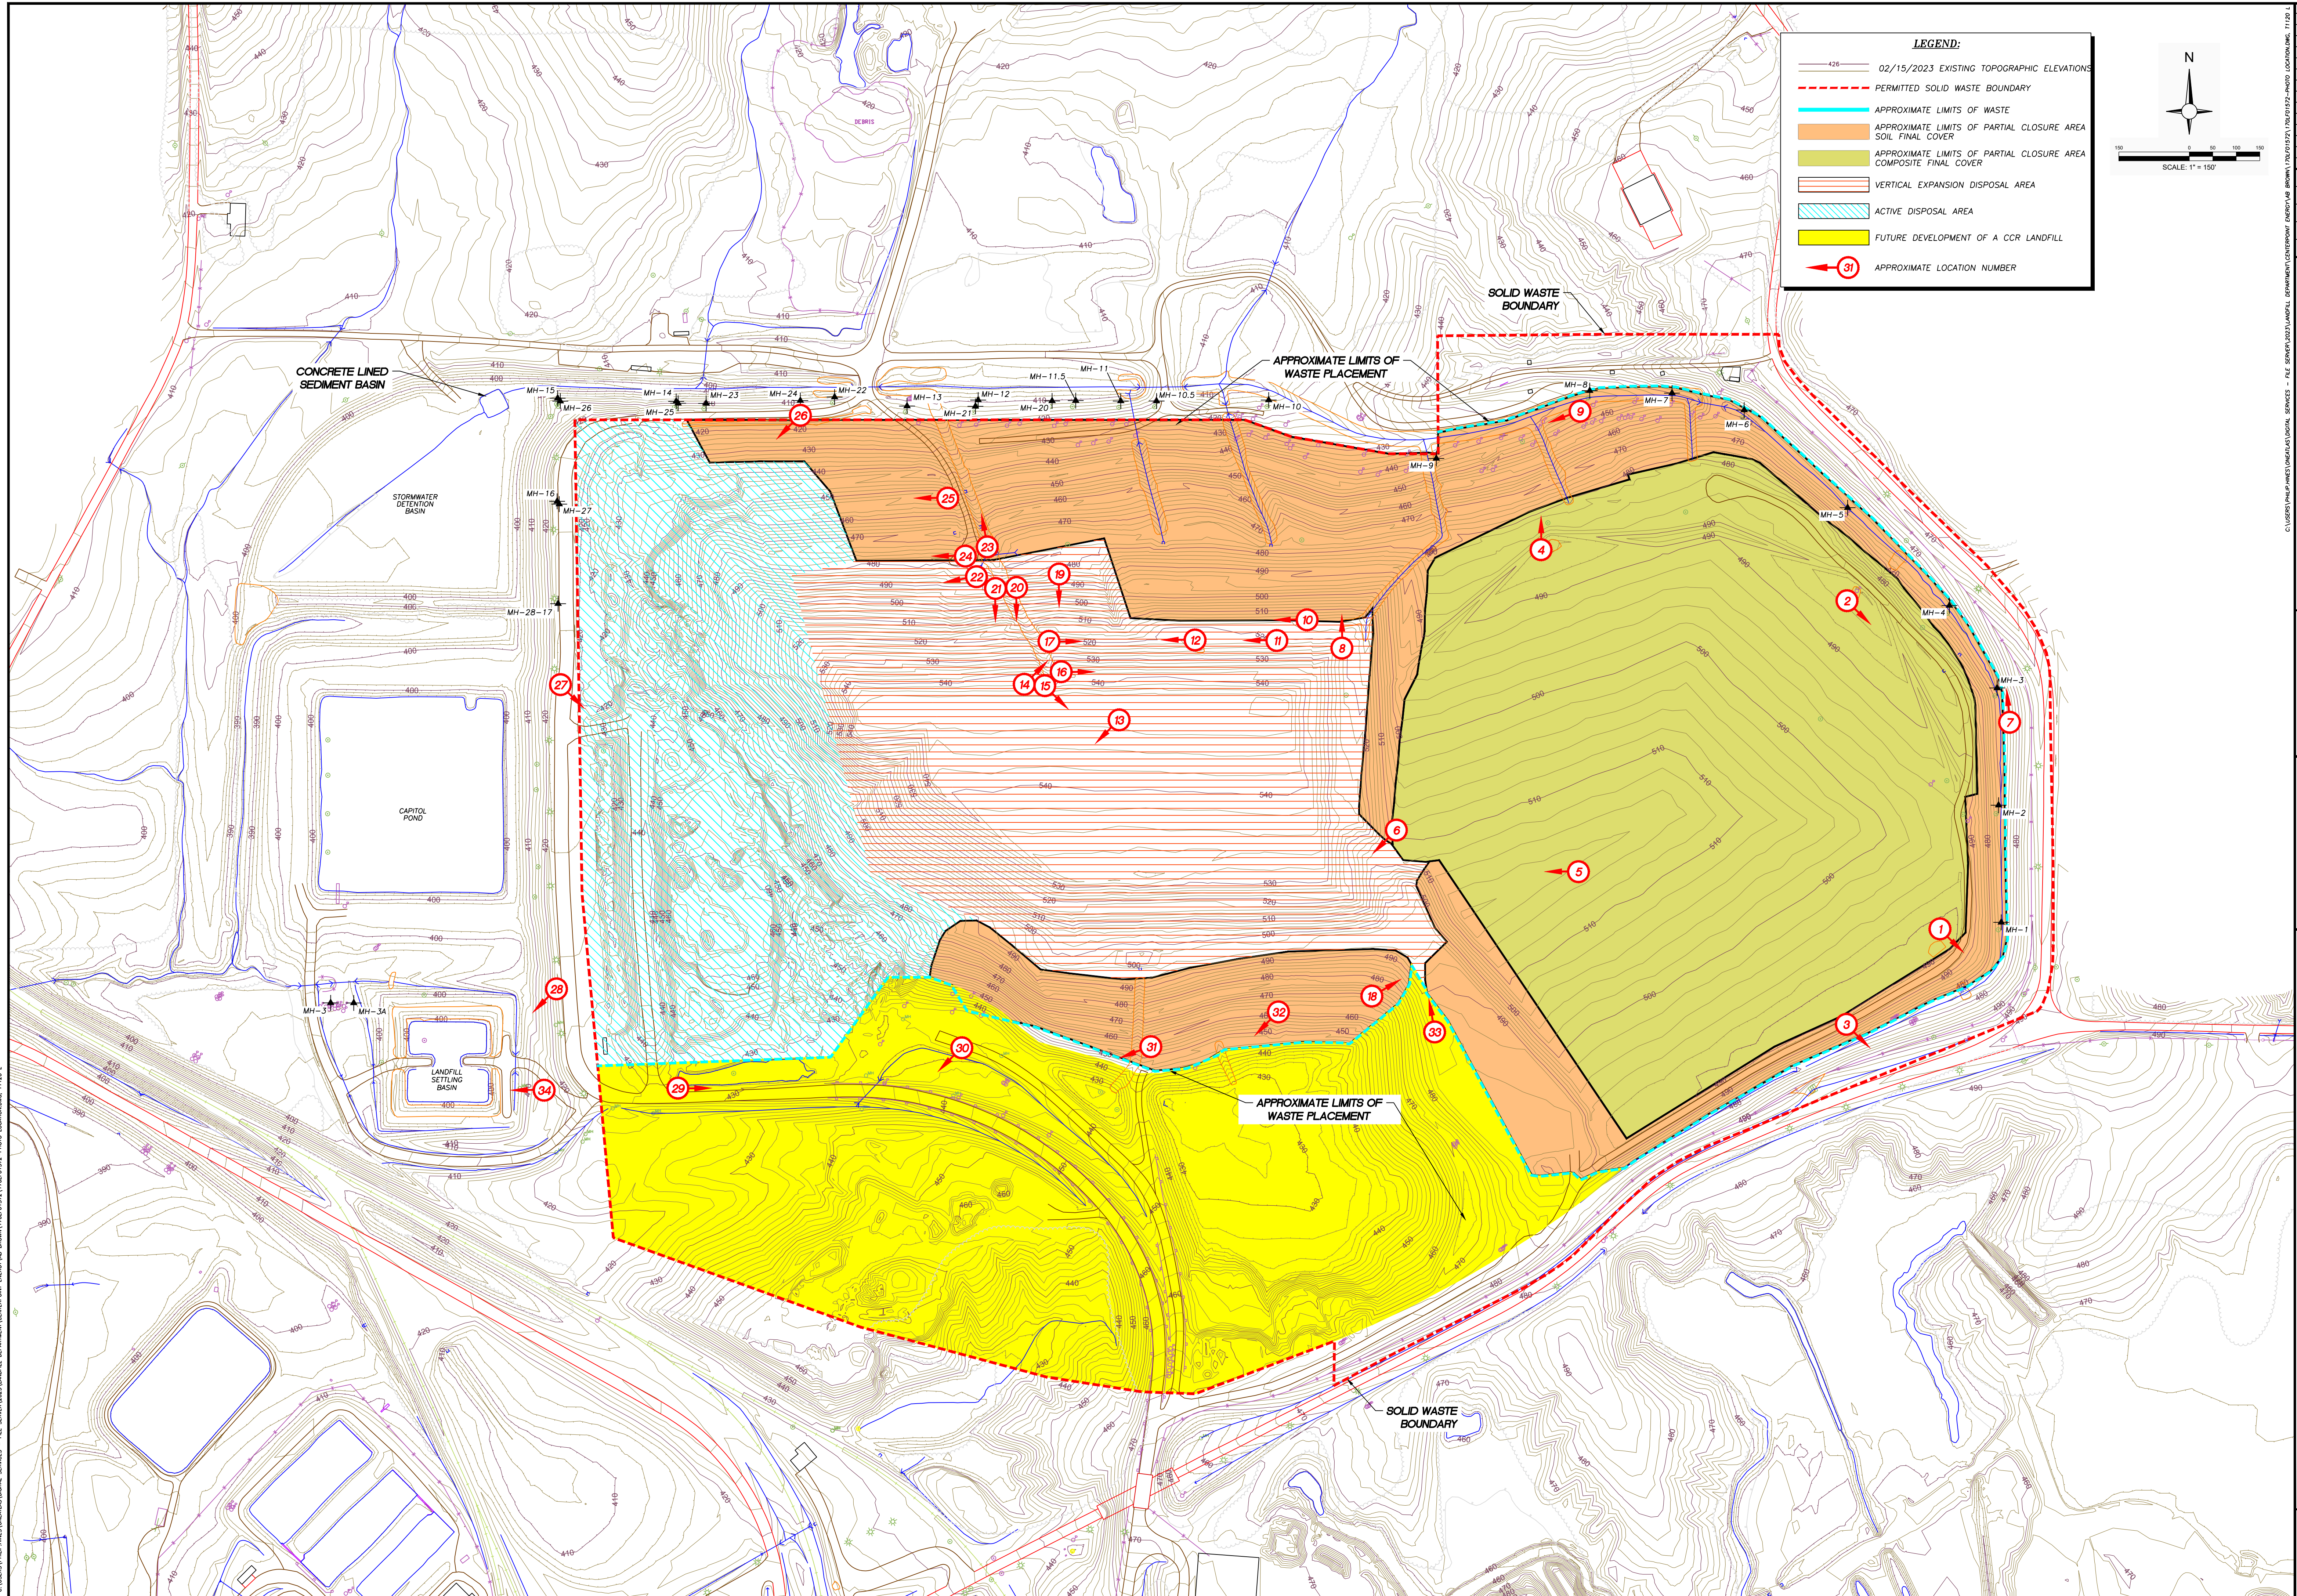
Drawing Title:  
**SITE PLAN OF INSPECTION LOCATIONS  
TYPE III RWS LANDFILL  
8511 WELBORN ROAD  
MOUNT VERNON, INDIANA 47620**

- 2) Observed sparse vegetation of the Final Cover (Locations 5, 9, 13, 17, 19, 24, and 31).

- 3) Although most drop inlets were in good conditions, a few isolated areas near some drop inlets exhibited excess vegetation growth and erosion at the time of the inspection (Locations 1, 2, and 4).

- 4) Tall vegetation growth was observed along the edge, on side slopes, and within some drainage channels on the north side of the landfill and near an outlet drainage pipe, on the northeast side of the landfill (Locations 8, 11, 12, 16 and 23). Site personnel clarified that the tall vegetation

- 5) A fallen solid waste boundary sign was observed on the north side of the landfill (Location 21).

- 6) A fallen bollard around piezometer PZ-M5 was observed on the east side of the landfill (Location 3).

- 7) A recently installed roadside ditch on the north side of the landfill does not have adequate protection to erosion (Location 26).

- 2) Erosion rills, gullies have formed on the middle north slope of the Vertical Expansion Disposal Area (Locations 6, 10, 14, 15, 18, 20, 21, 22, 25, 30, and 33).

- 3) Erosion was observed at an outlet drainage pipe on the north side of the Vertical Expansion Disposal Area (Location 32).

- 2) Surface water runoff from the northern portion of the Active Landfill Area is routed to a depression at the far north end (Locations 27) and southwest corner (Location 29).

**The inspection conducted on November 29, 2023 did not reveal any signs of imminent failure for the landfill. However, there are isolated areas of erosion that require repair and/or modification as part of the ongoing maintenance of the landfill area.**

**There were no signs of structural weakness noted within the permitted solid waste boundary at the time of this visual inspection. Additional temporary erosion and sediment controls should be deployed in the Vertical Expansion Disposal Area.**

**Recommendation: Areas of sparse vegetation should be reseeded with similar grasses to the ones at the site, and temporarily isolated to prevent trampling and help re-establish grass cover.**

**Recommendation: Remove excess vegetation and repair erosion by establishing a new vegetation cover.**

**Recommendation: Replace fallen sign.**

**Recommendation: Replace fallen bollard.**

**Recommendation: Install riprap along ditch section to prevent erosion and deterioration of access road.**

**Recommendation: Repair rills, install erosion control blankets and/or other erosion BMPs, and reseed areas to re-establish grass cover.**

**Recommendation: Install riprap at the outlet of the drainage pipe.**

**Recommendation: Monitor these areas during and after significant storm events to maintain adequate freeboard.**
