October 13, 2016

CCR Certification:
Initial Structural Stability
Assessment
§257.73 (d)

East Ash Pond

F. B. Culley Generating Station

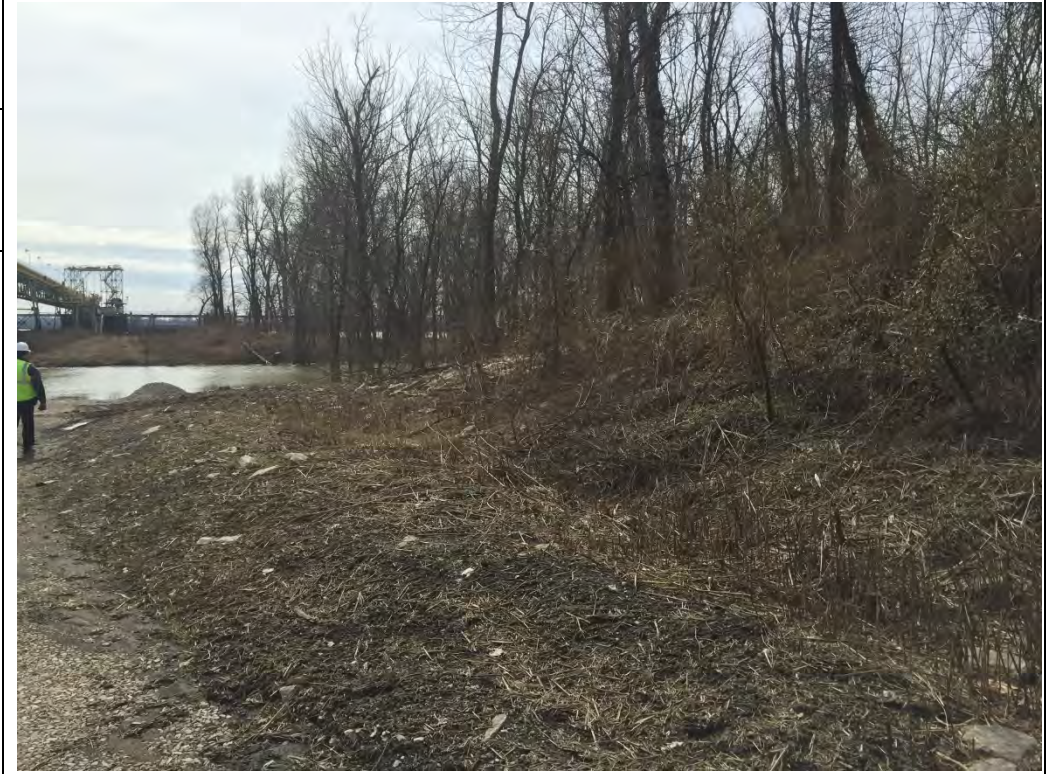
<p>Photo No. 5</p>	<p>Date: 02/23/2016</p>

<p>Location: F.B. Culley Generating Station</p>		
<p>Description: Standing along the base of the west side of the impoundment, looking south.</p> <p>Picture shows adequate slope protection and no evidence of seepage.</p> <p>Photographer: Entwistle</p>		
<p>Photo No. 6</p>	<p>Date: 02/23/2016</p>

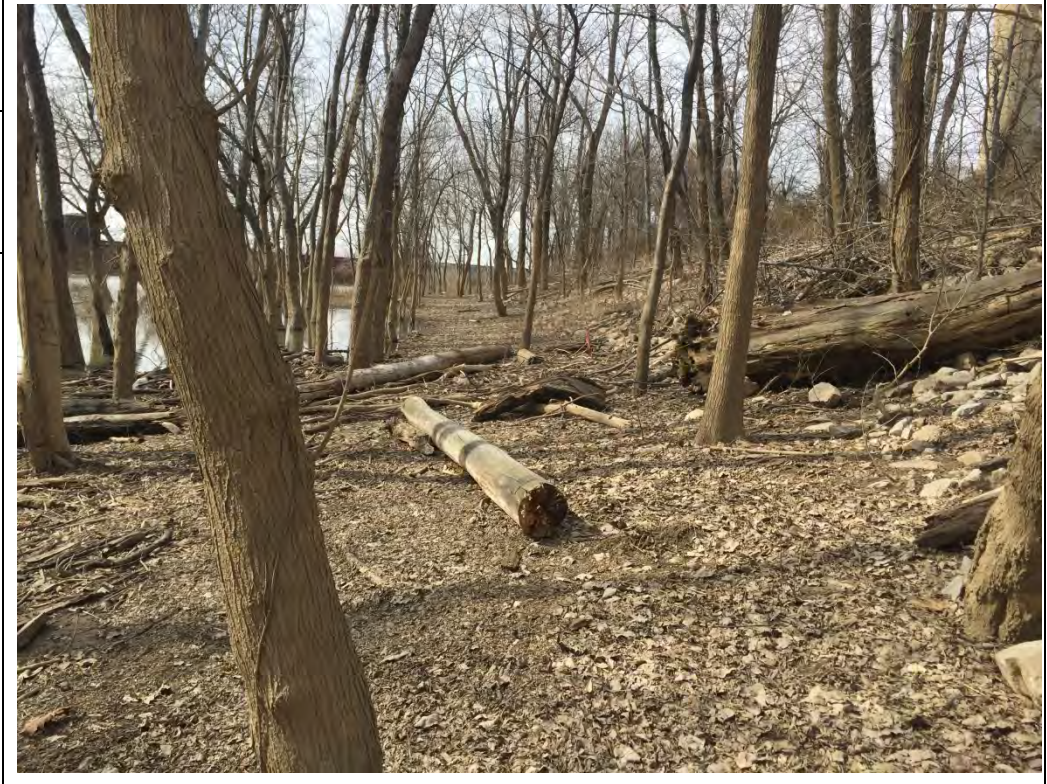
<p>Location: F.B. Culley Generating Station</p>		
<p>Description: Standing along the base of the south side of the impoundment, looking east.</p> <p>Picture shows adequate slope protection and no evidence of seepage or sloughing.</p> <p>Photographer: Entwistle</p>

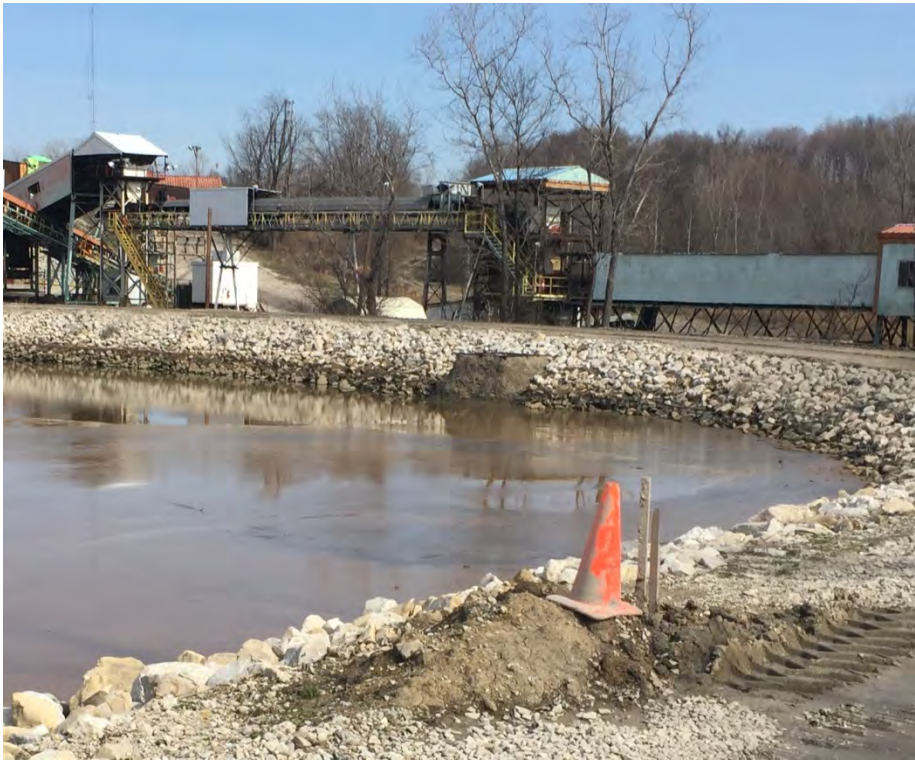
<p>Photo No. 7</p>	<p>Date: 02/23/2016</p>

<p>Location: F.B. Culley Generating Station</p>		
<p>Description: Standing on the southeast corner of the berm looking at plugged and abandoned auxiliary spillway.</p> <p>Photographer: Entwistle</p>		
<p>Photo No. 8</p>	<p>Date: 11/04/2015</p>

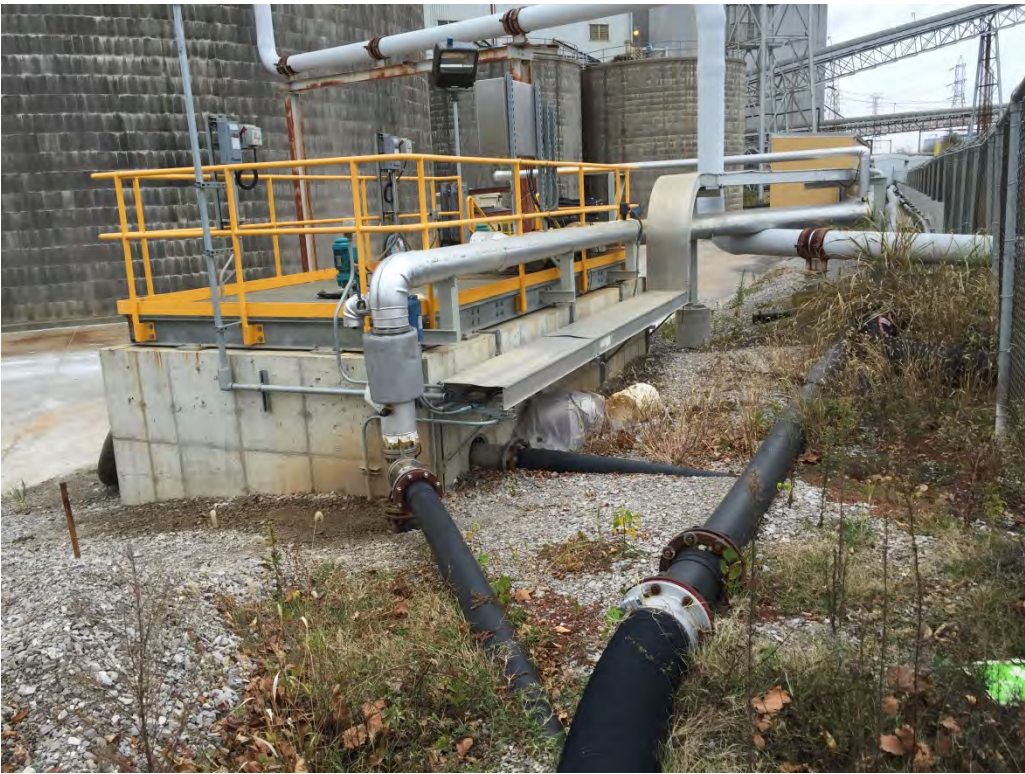
<p>Location: F.B. Culley Generating Station</p>		
<p>Description: Pumping station for discharge into and out of surface impoundment.</p> <p>Photographer: Entwistle</p>
