October 11, 2024

CCR Annual Inspection §257.83 (b)

East Ash Pond

F. B. Culley Generating Station

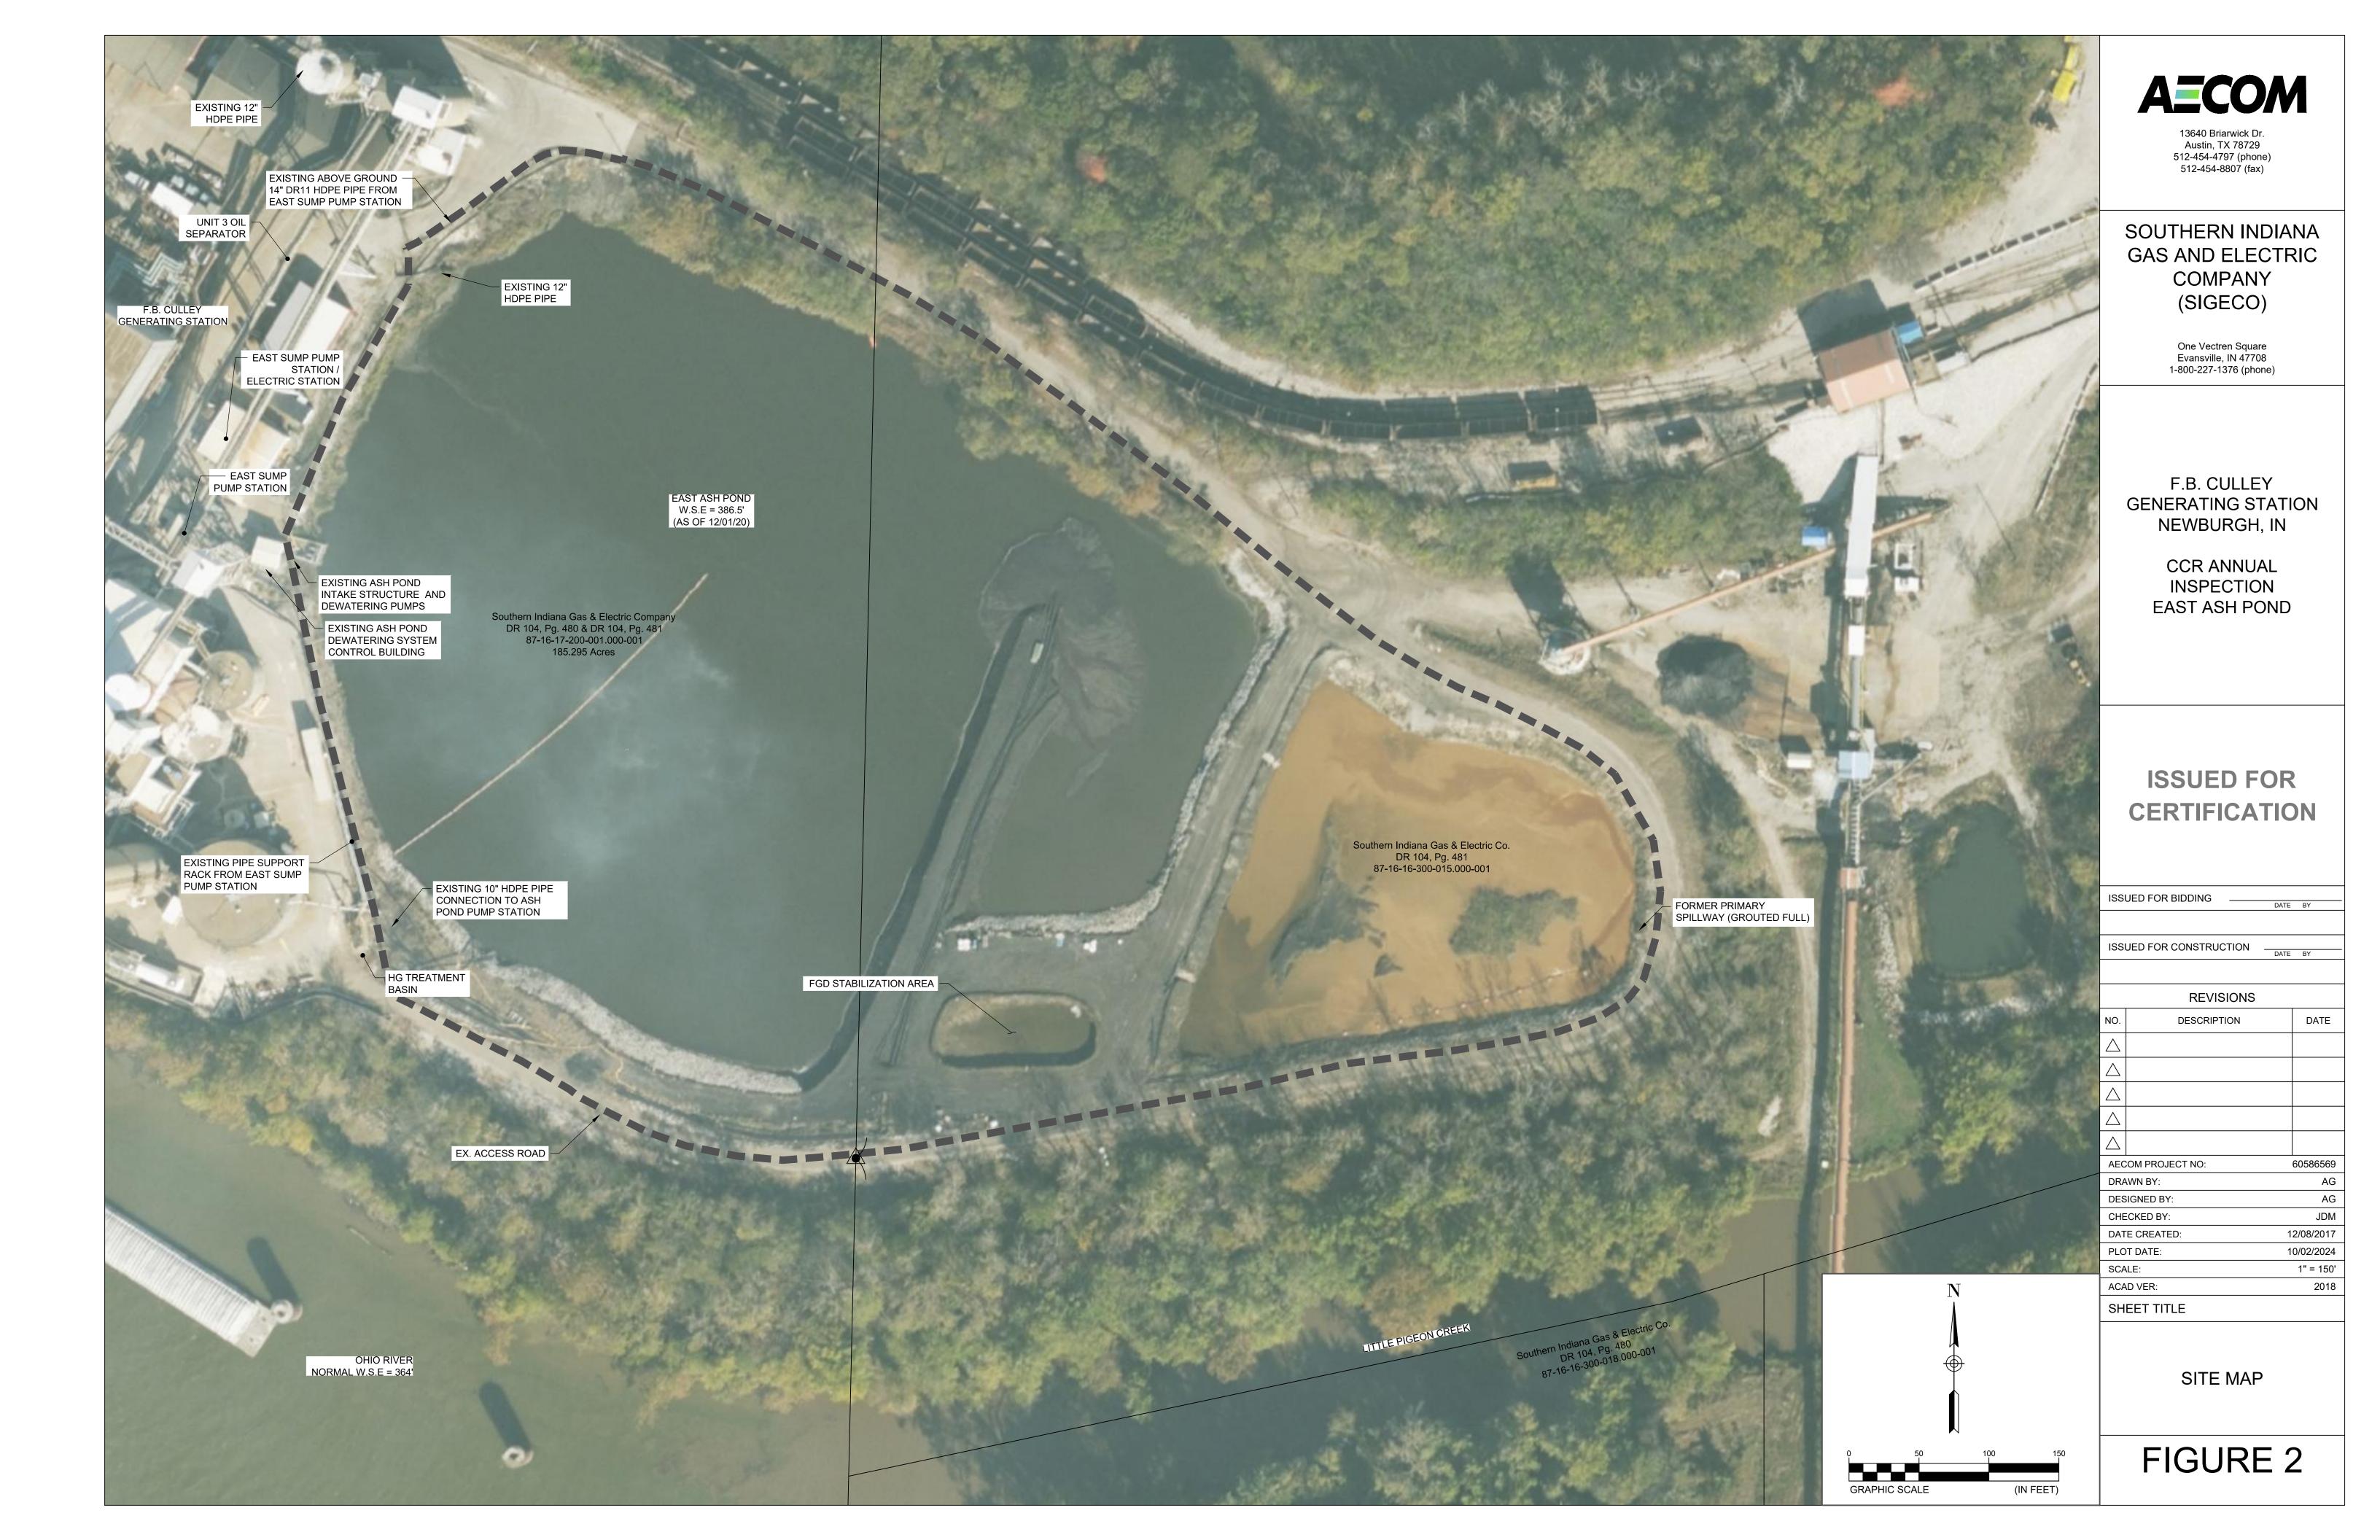
Figure 2 – Site Map

A site Location Map showing the area surrounding the Station is included as **Figure 1** of **Appendix A**. **Figure 2** in **Appendix A** presents the Culley Site Map.

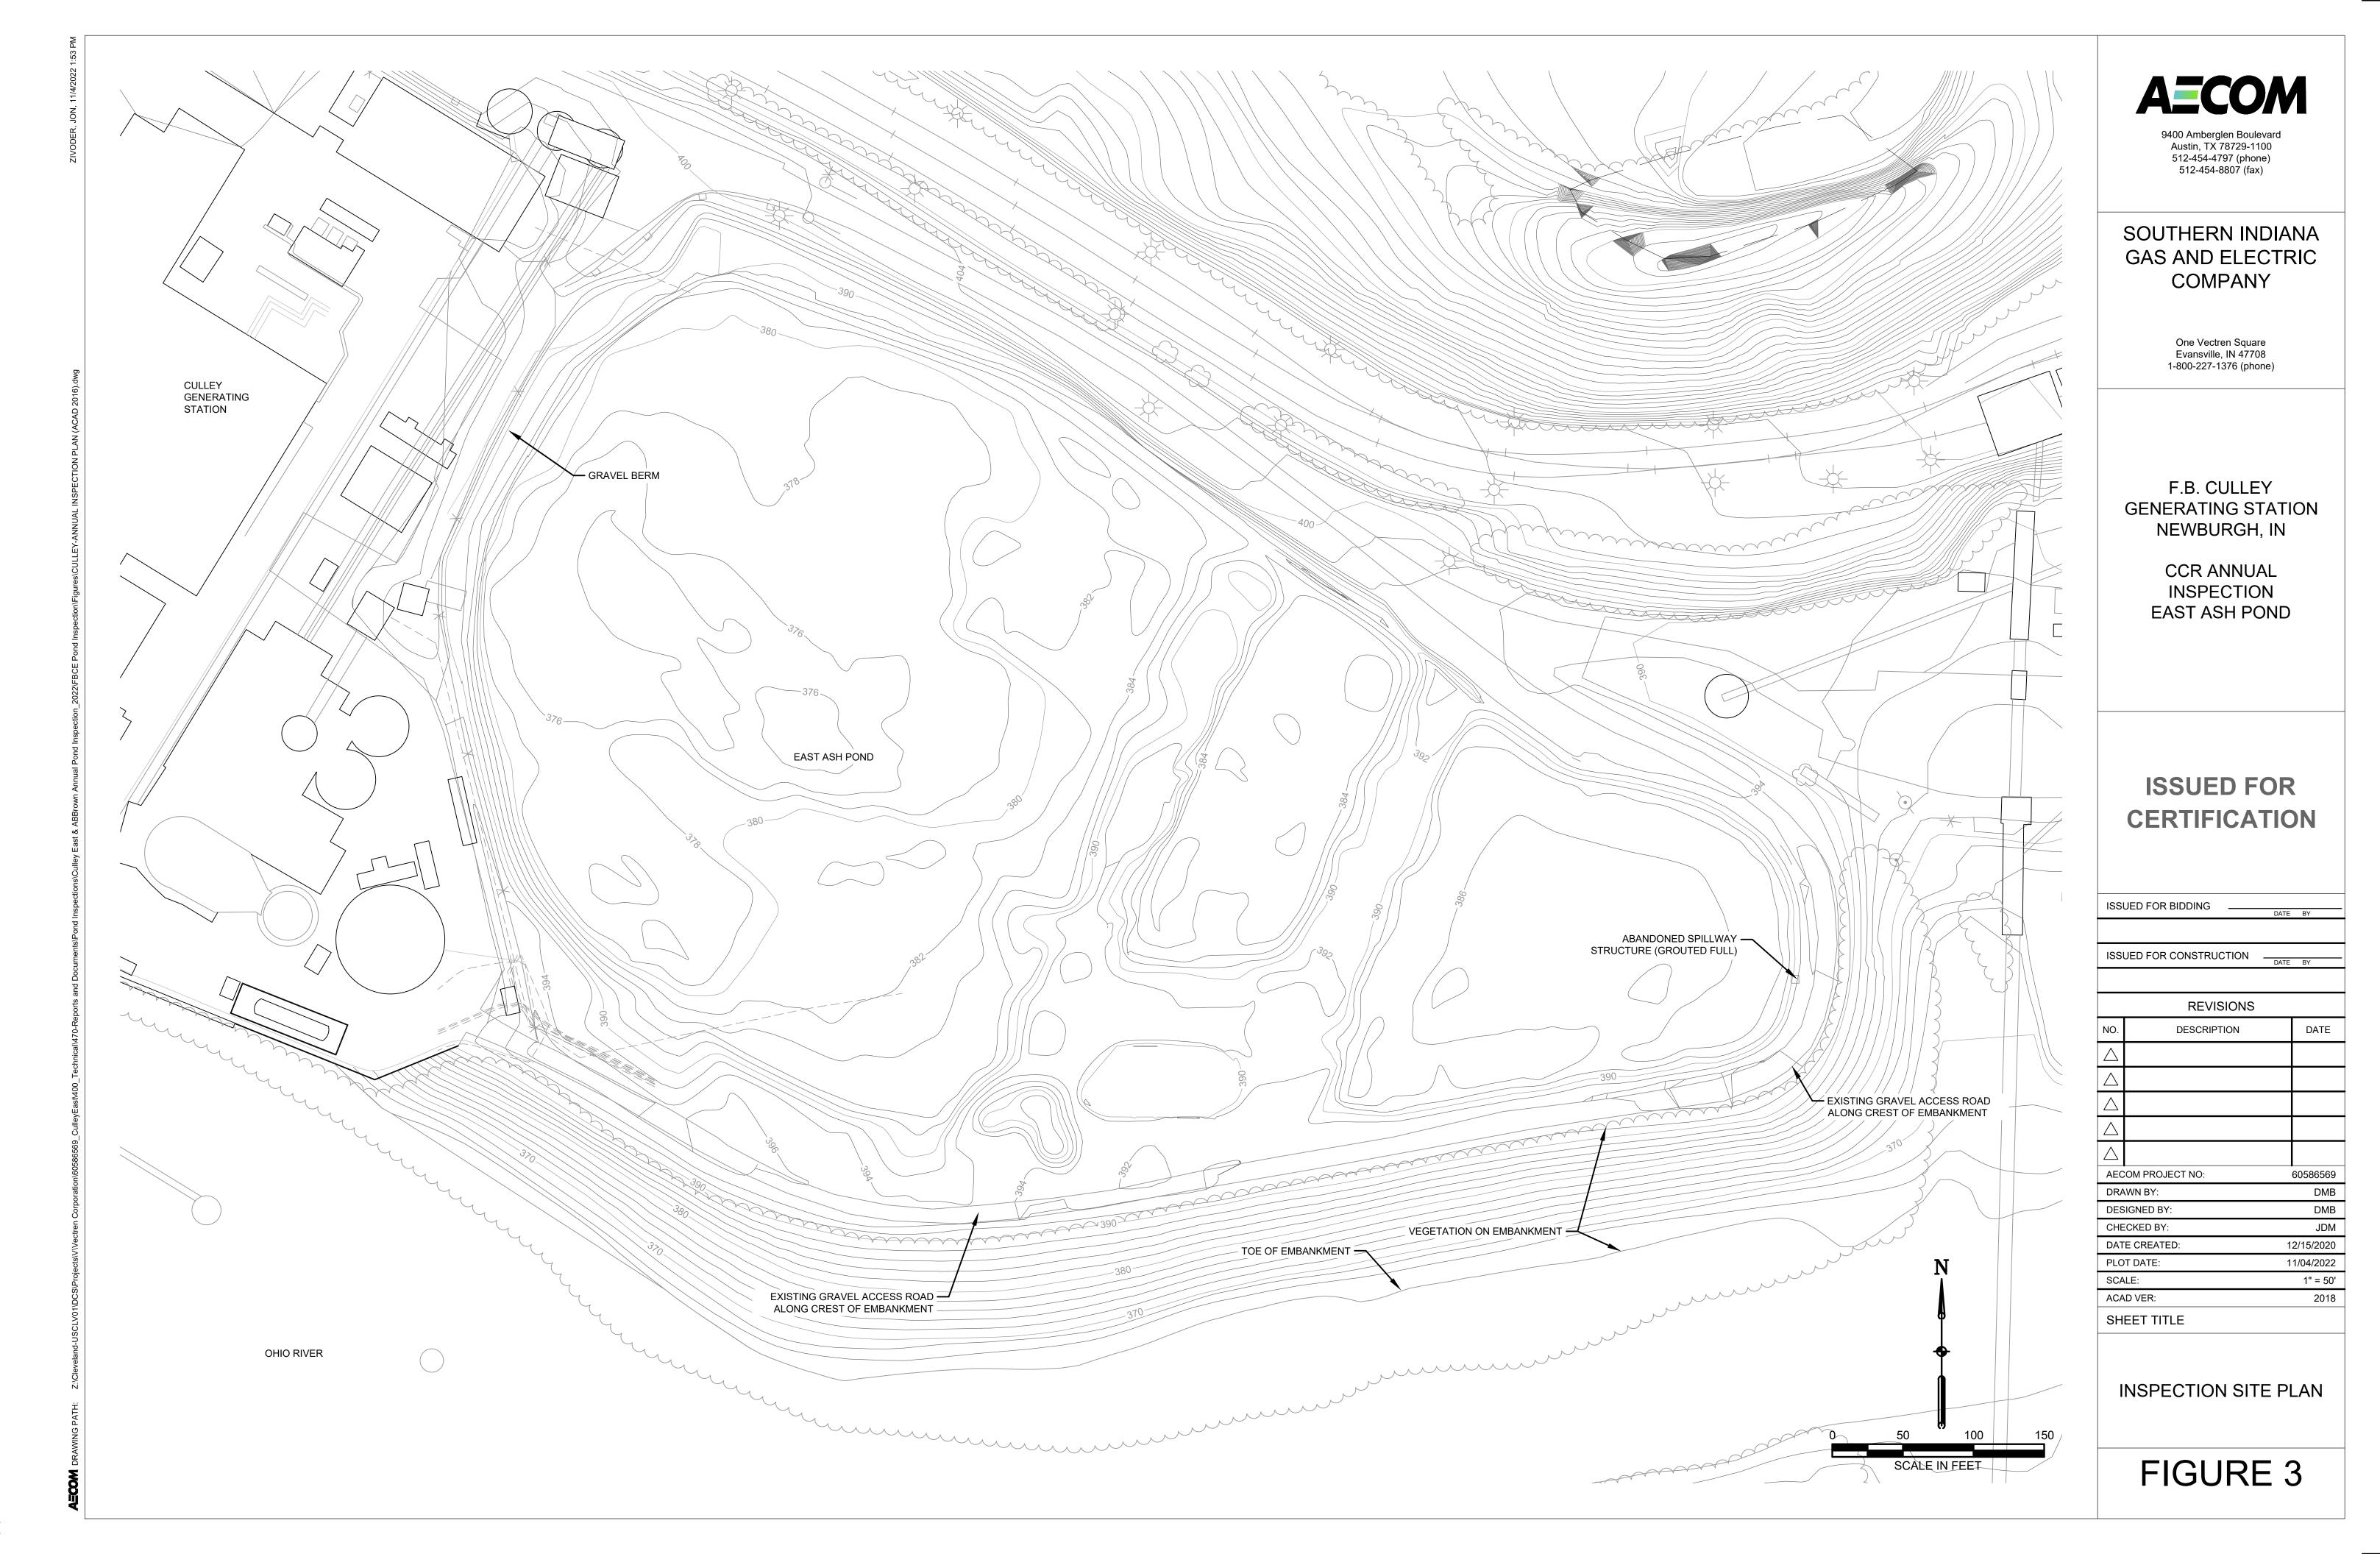
Figure 3 – Inspection Site Plan

The East Ash Pond was visually inspected by AECOM on September 17, 2024. No major signs of distress or malfunction of the CCR unit and appurtenant structures were identified, as also noted in Section 2.4.2.
