January 11, 2019

CCR Annual Inspection

East Ash Pond

F. B. Culley Generating Station

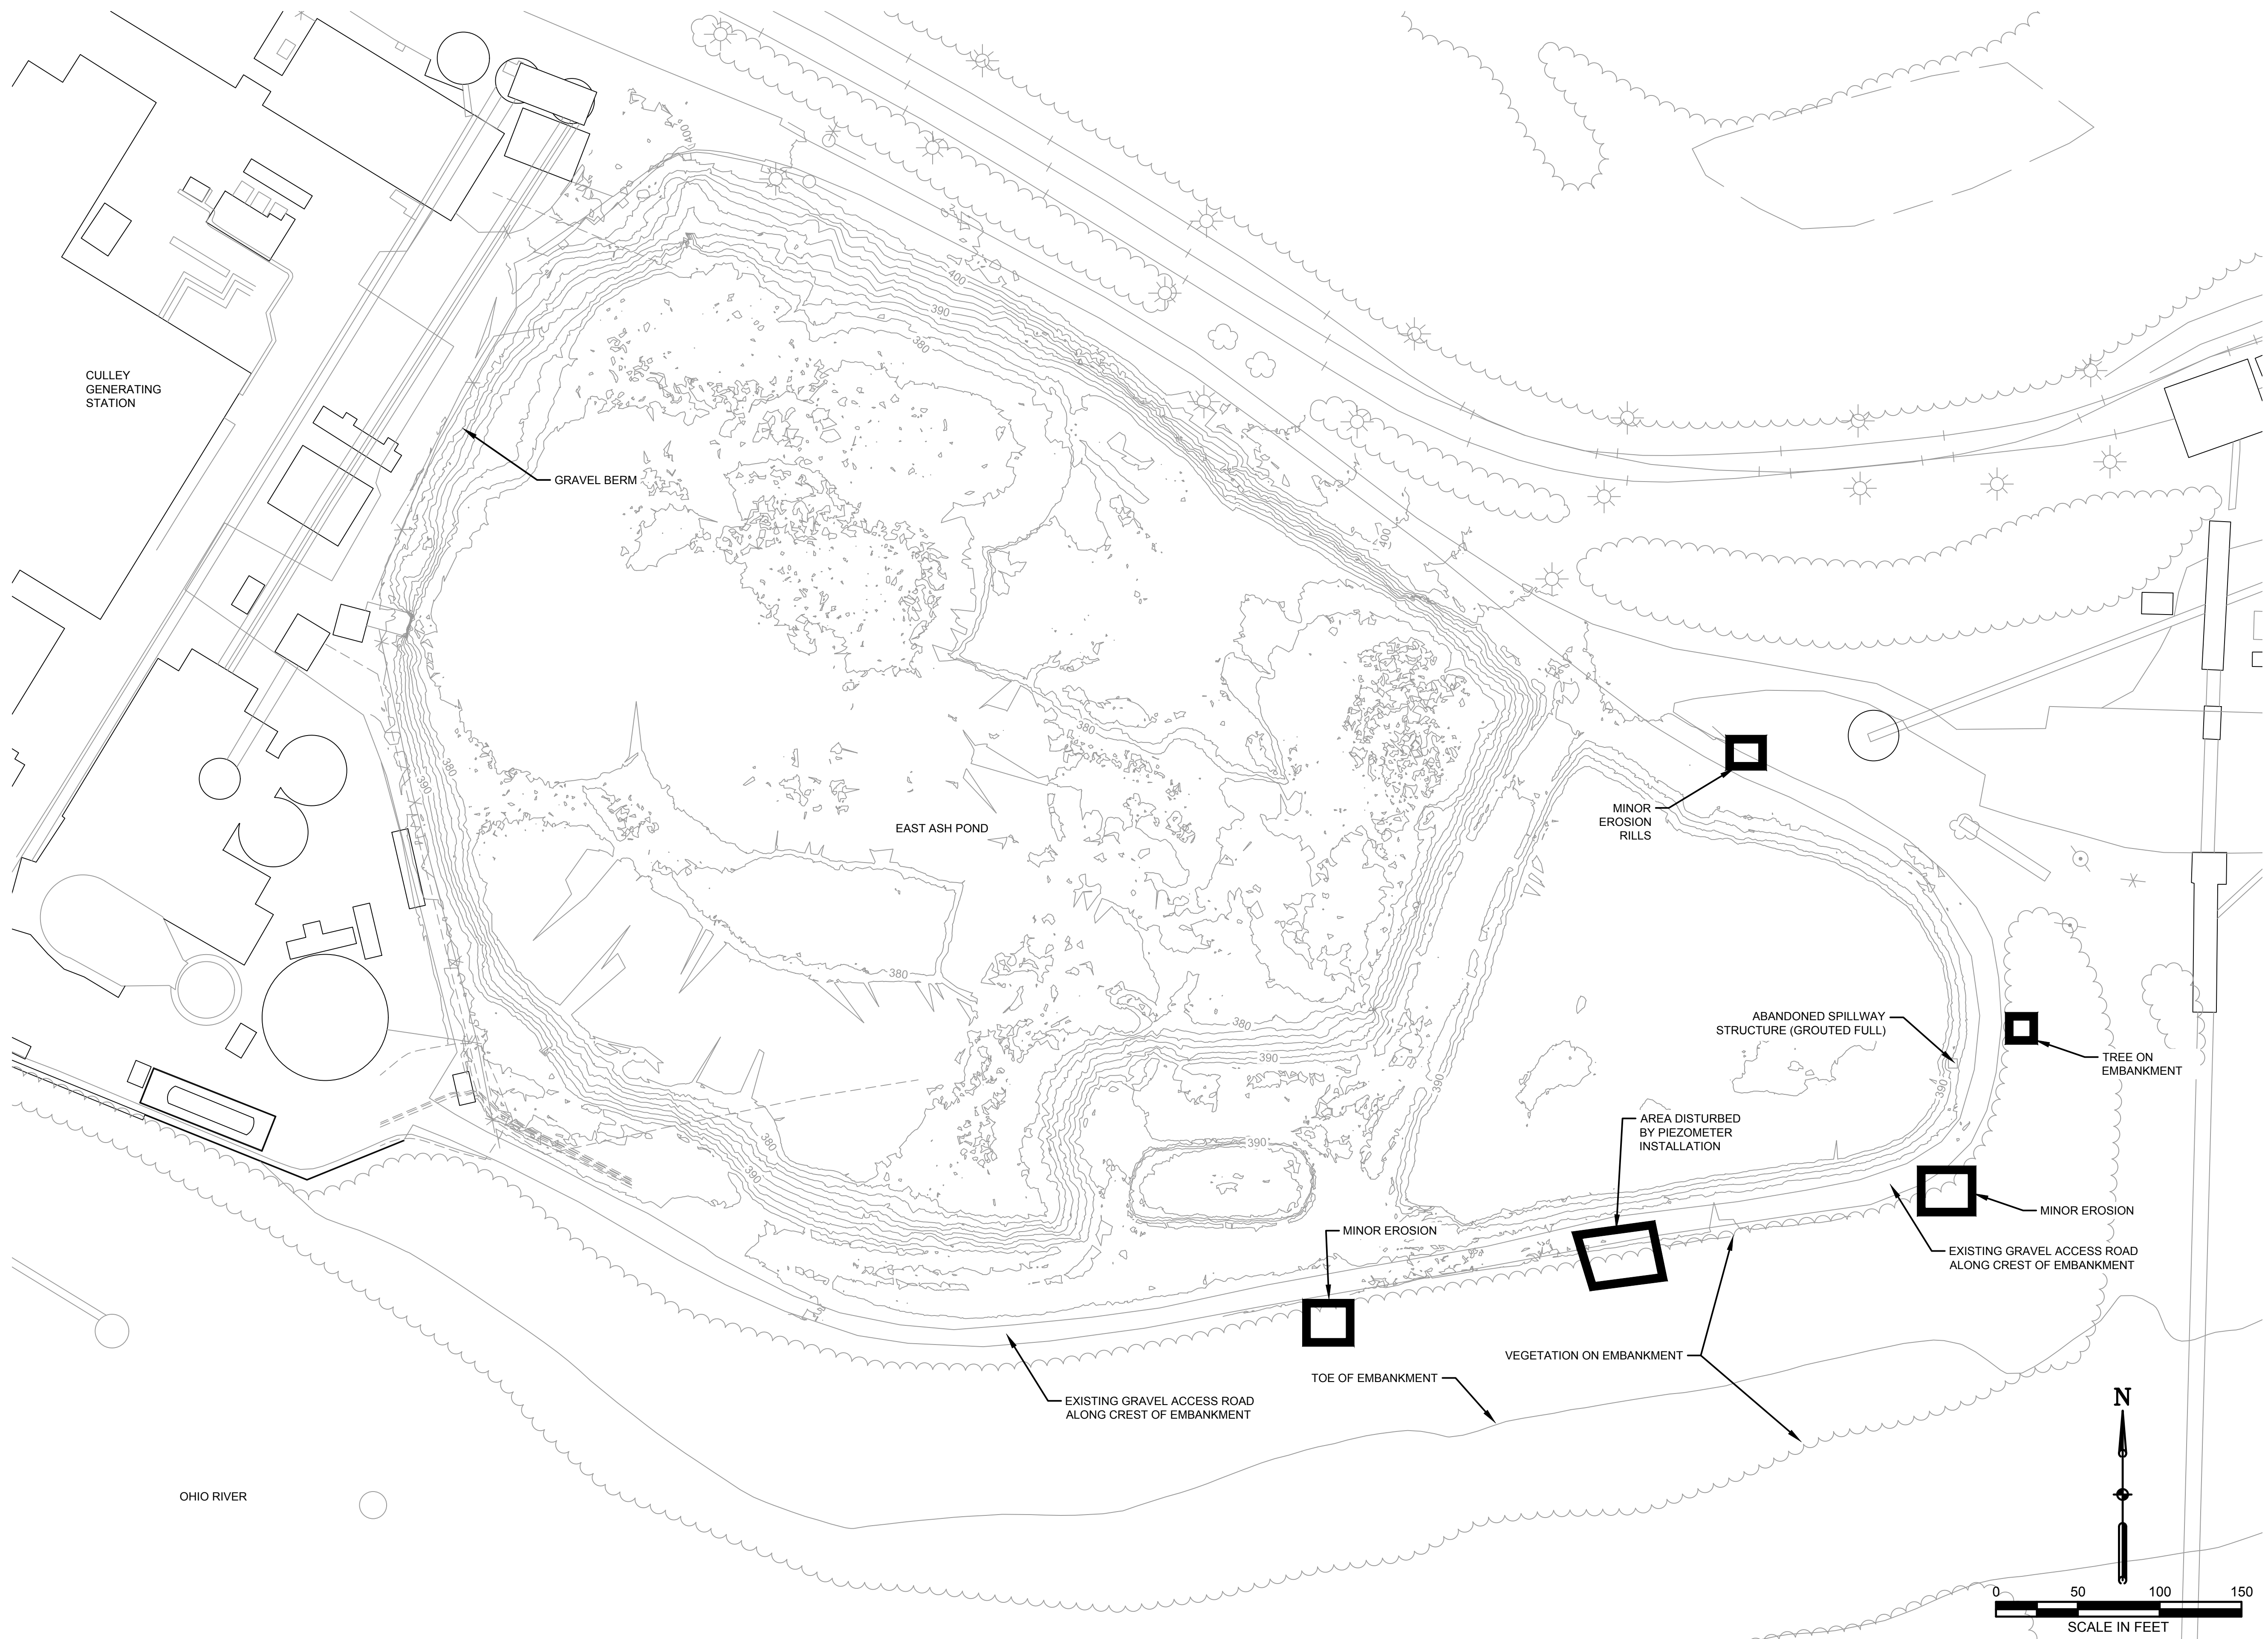
FIGURE 3

Table 2-3 – Areas of Concern (Inspected: December 6, 2018)	
Deficiency/Observation	Proposed Corrective Measure
Minor erosion rills on embankments on the downstream side of the crest's edge. See attached plan.	Eroded areas shall be regraded and reseeded as necessary.
A piezometer was installed recently, and the area around it has no vegetation or other erosion protection. See attached plan.	The area around the piezometer should be regraded and reseeded.
A small tree is present on the eastern embankment	The tree should be removed and the resulting cavity filled

<p>of the pond. See attached plan.</p>	<p>with compacted cohesive soil. The vicinity should be reseeded.</p>
--	---
