January 8, 2021

CCR Annual Inspection

East Ash Pond

F. B. Culley Generating Station

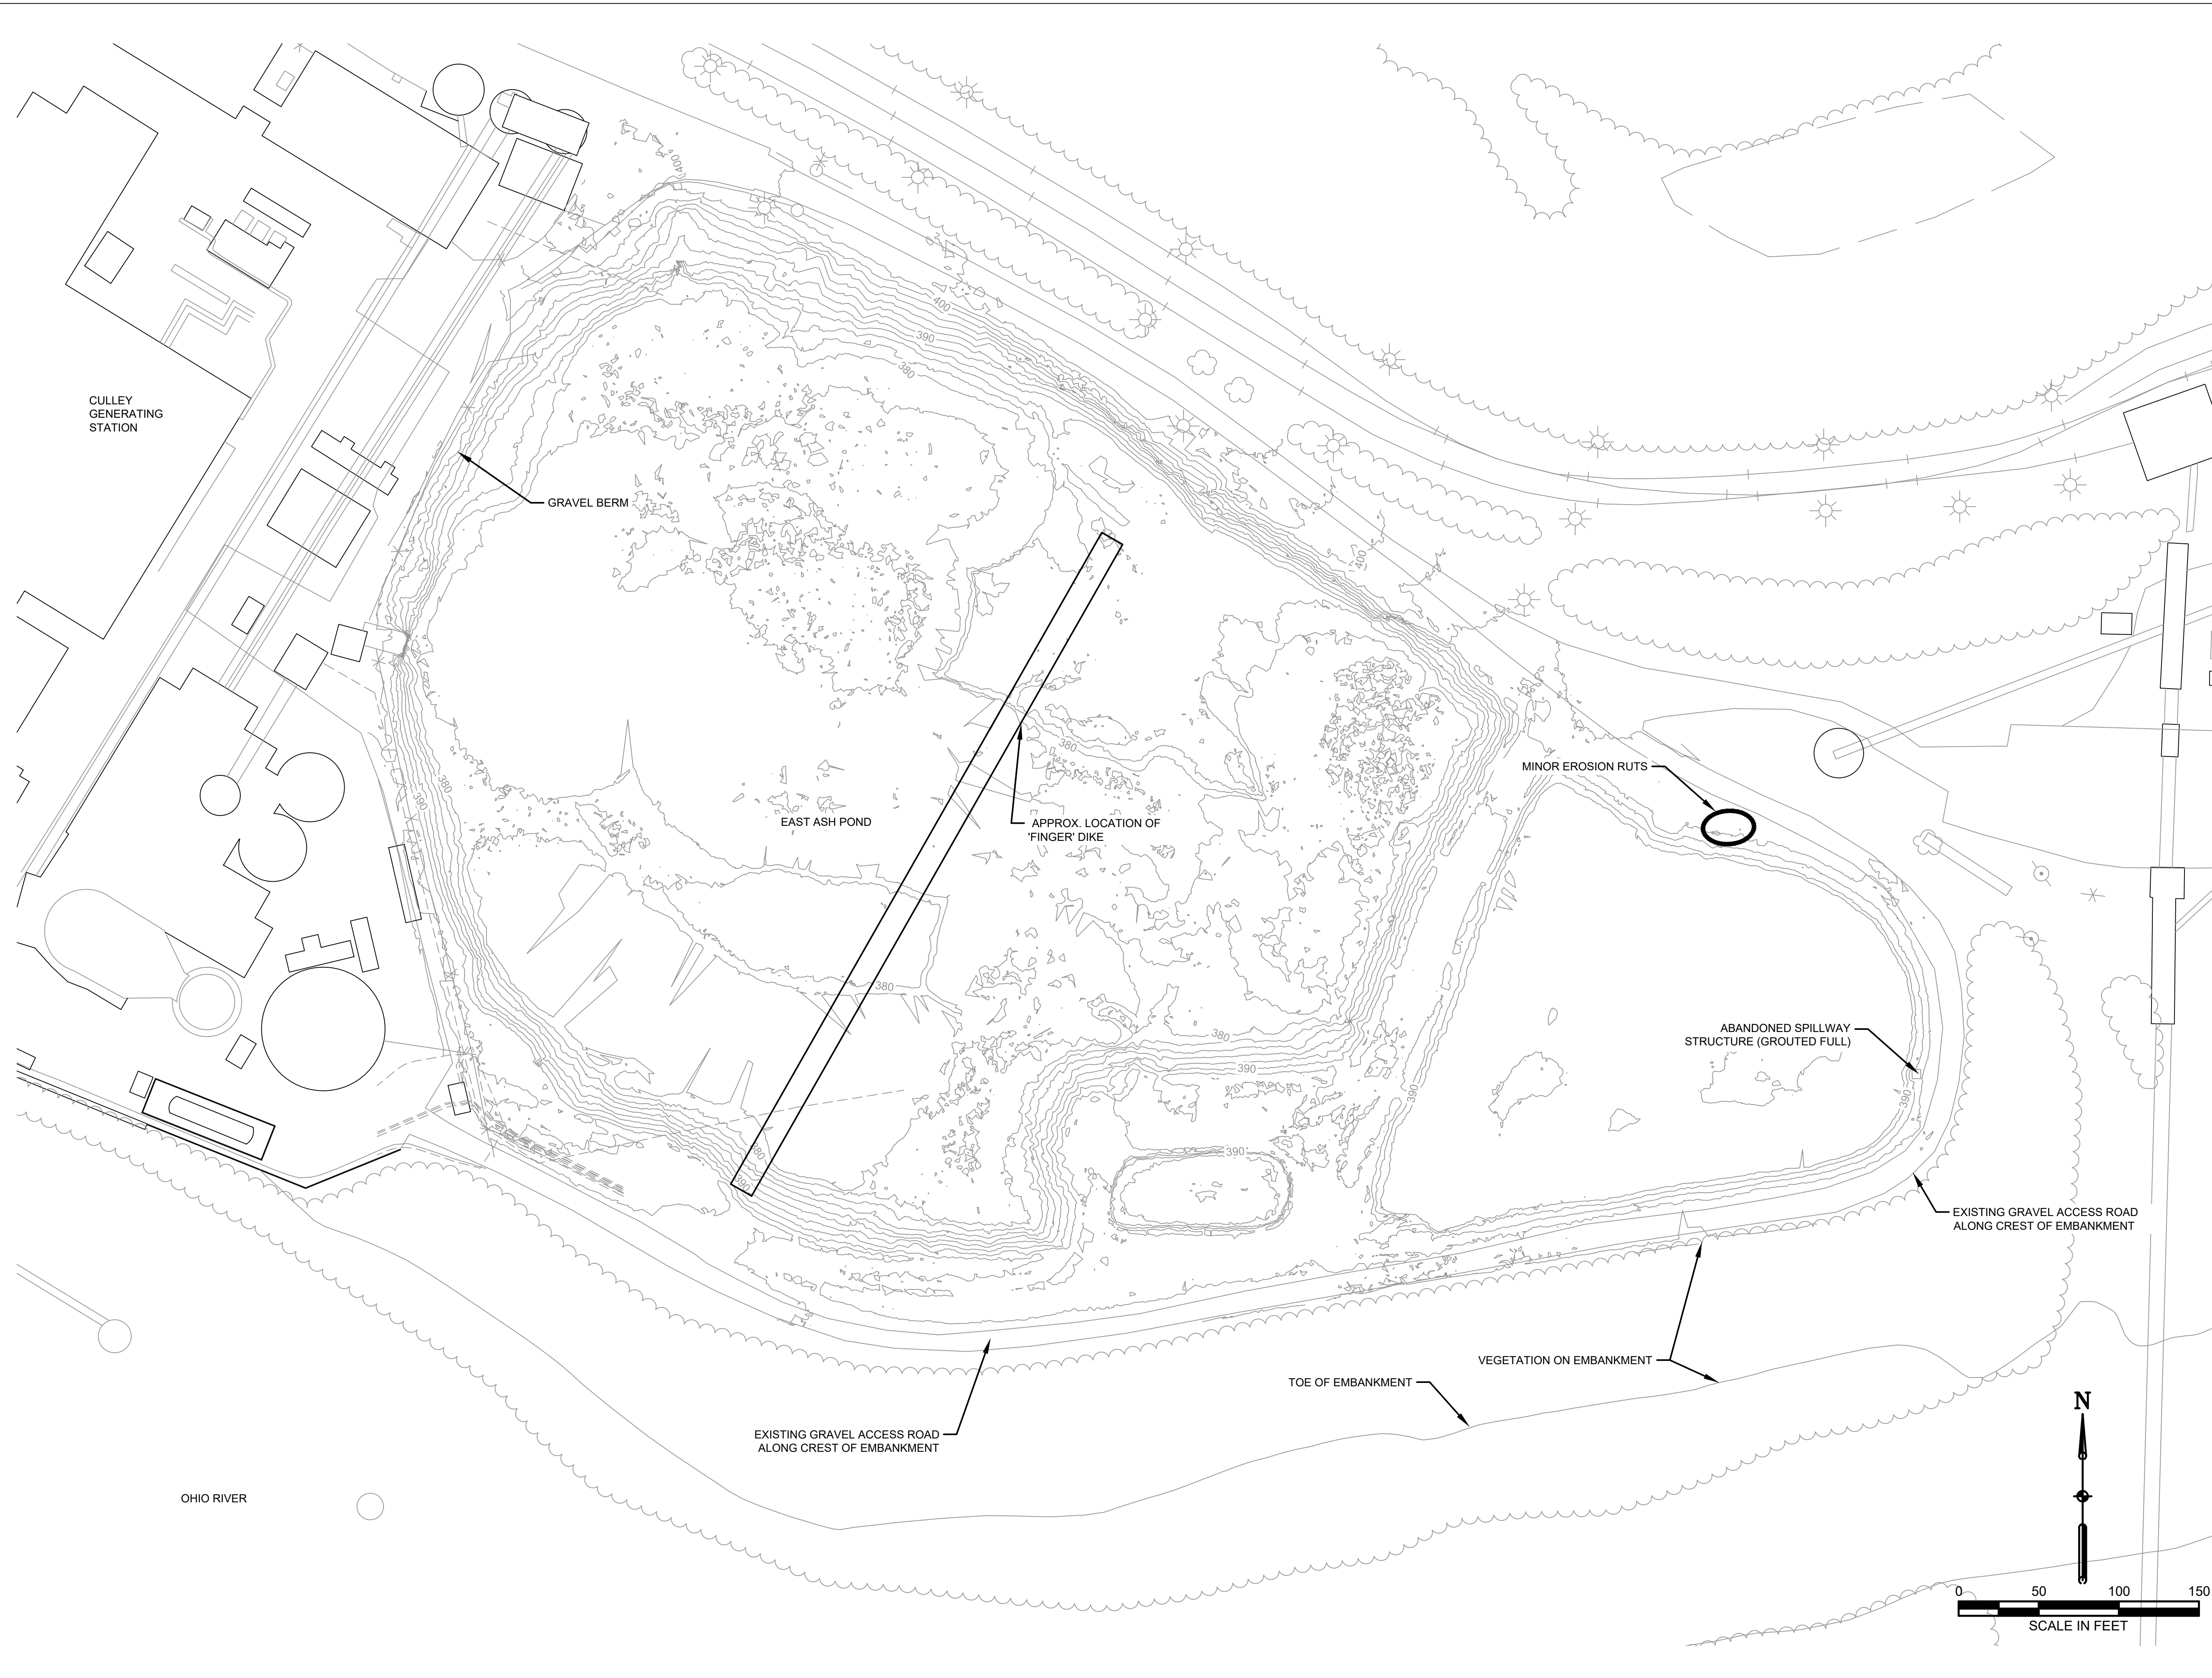
INSPECTION SITE PLAN

Table 2-3 – Areas of Concern (Inspected: December 1, 2020)	
Deficiency/Observation	Proposed Corrective Measure
Minor erosion ruts on the northeast outer embankment slope adjacent to the hopper.	Eroded areas shall be regraded and reseeded as necessary.
Vegetation growth on multiple embankment slopes.	Vegetation shall be removed as part of scheduled maintenance.
