July 19, 2019

CCR Annual Inspection

West Ash Pond

F. B. Culley Generating Station

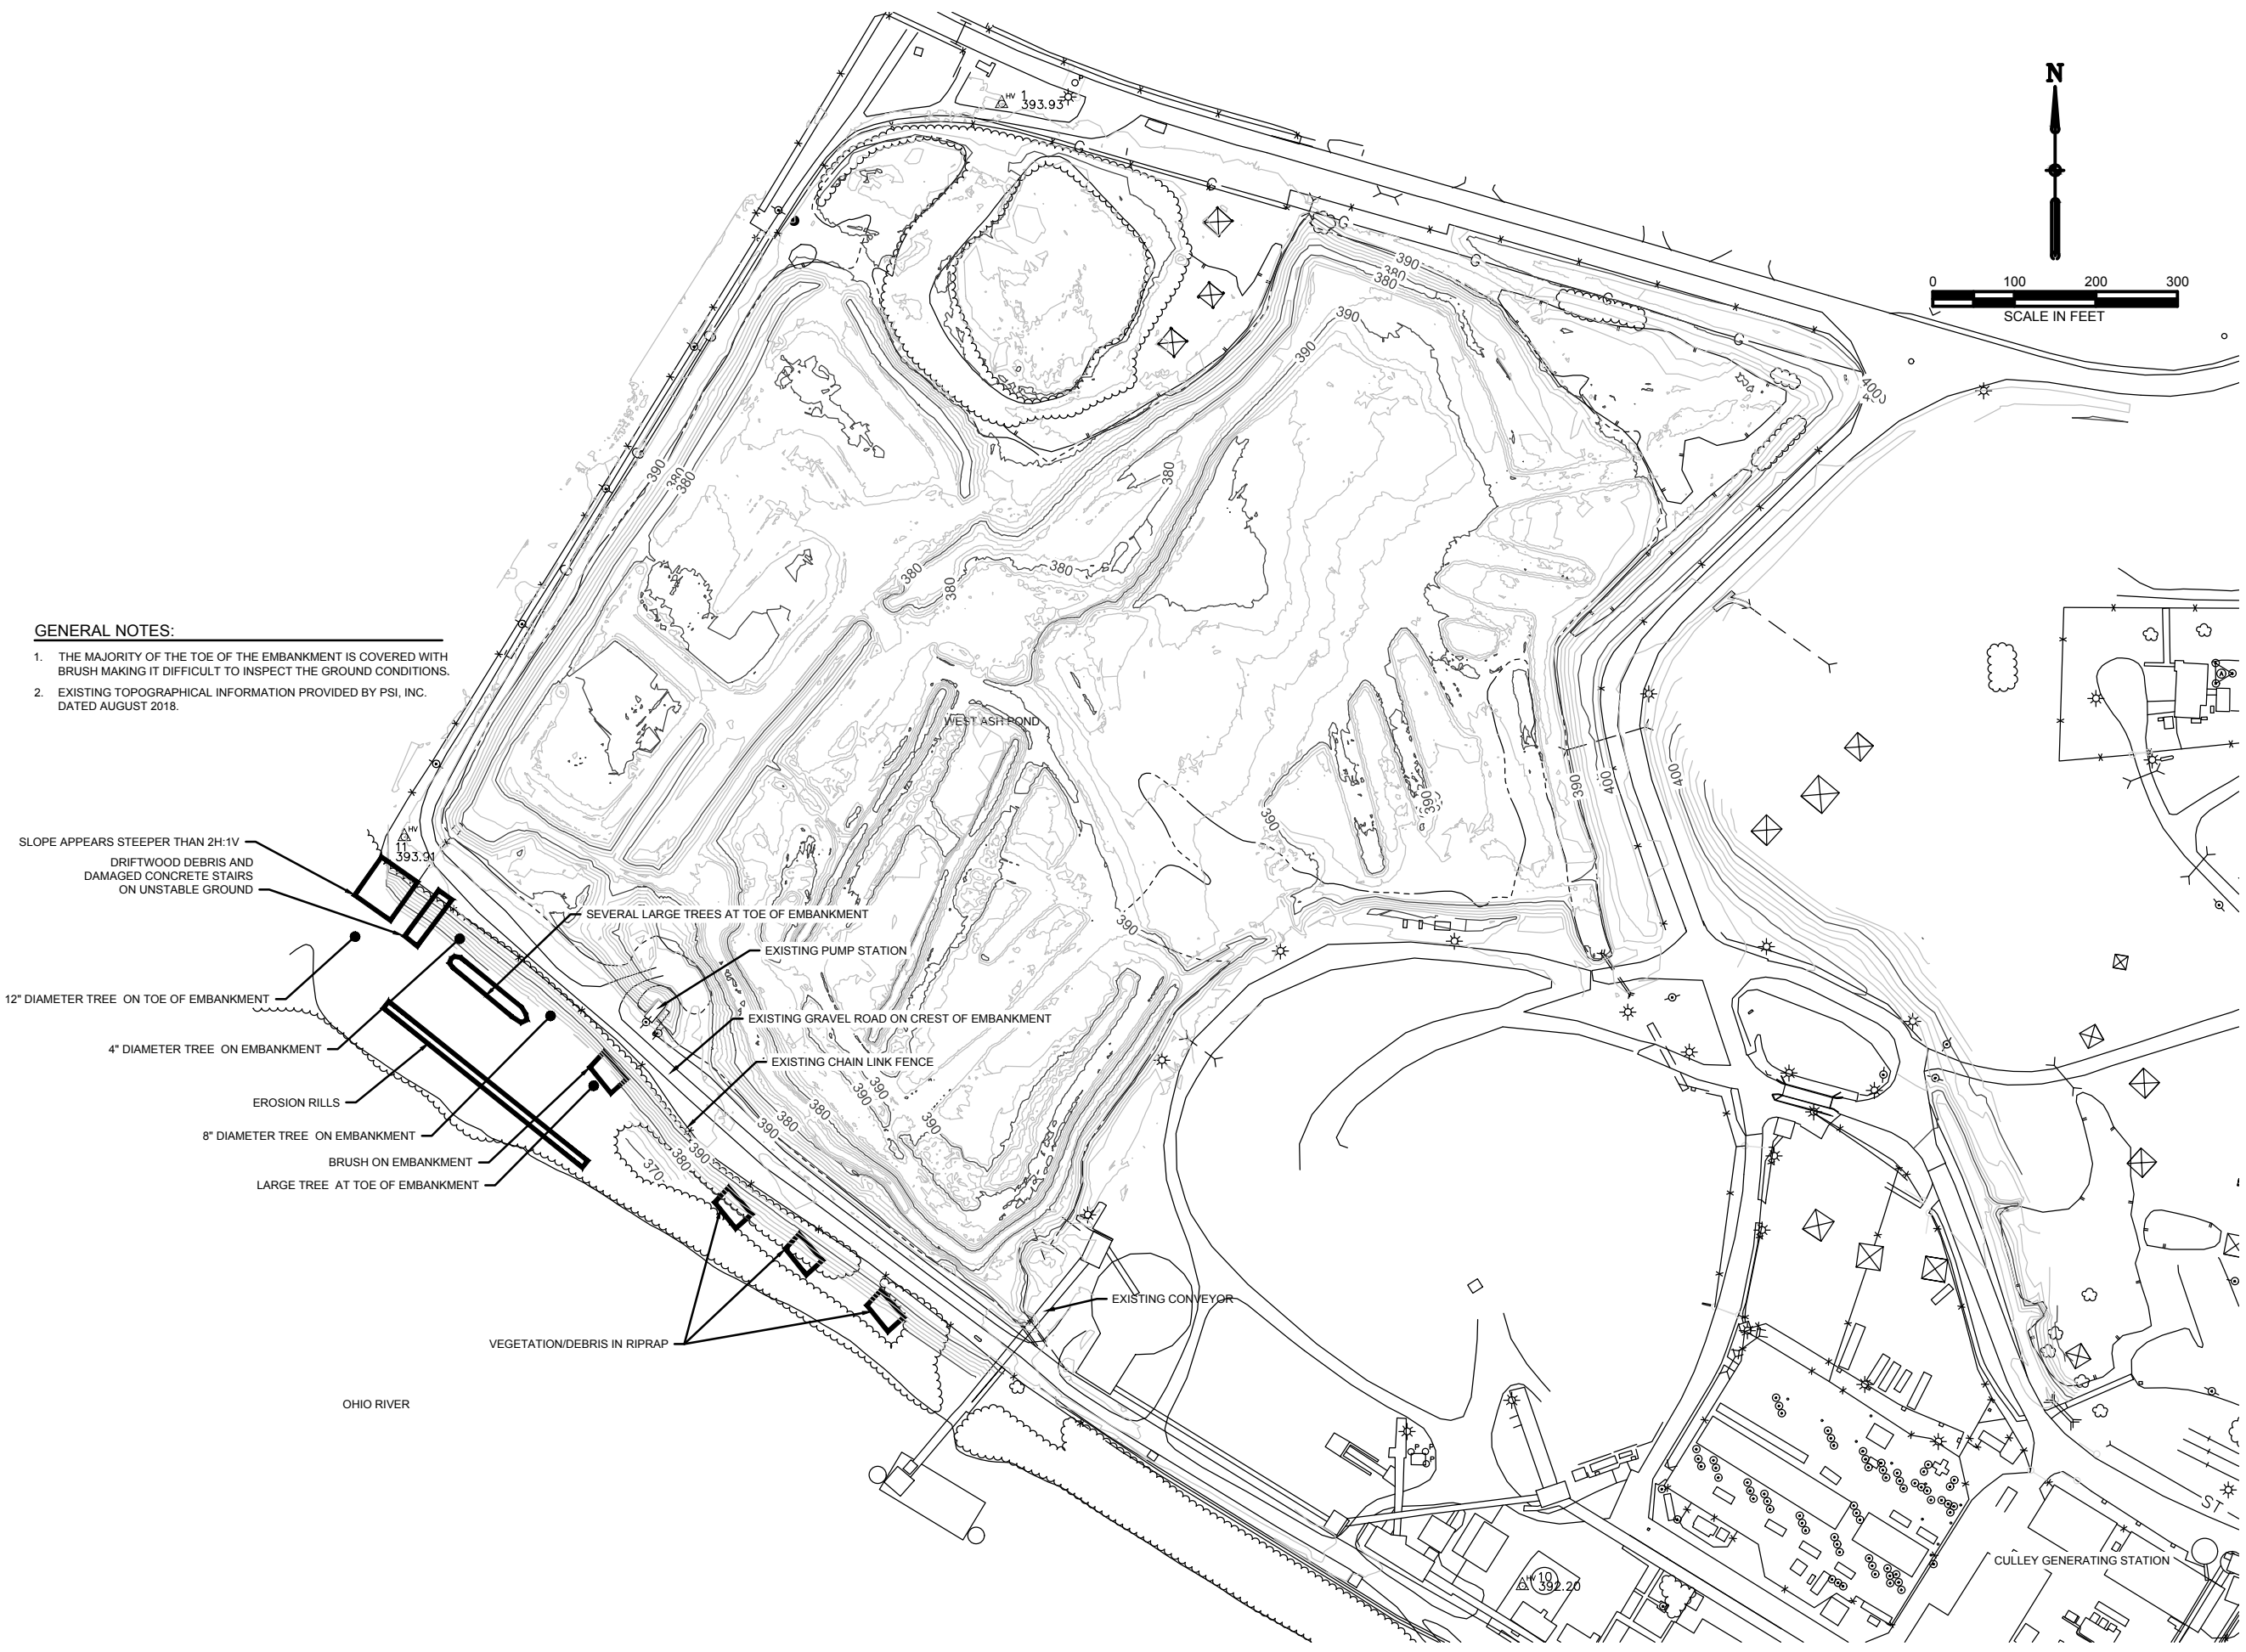
INSPECTION SITE PLAN

Table 2-3 – Areas of Concern (Current Inspection: May 20, 2019)	
Deficiency/Observation	Proposed Corrective Measure
Exterior Slope – A few small trees/bushes and brush have grown on the embankment slope.	Continue monitoring. Cut small trees/bushes to a level flush with the ground surface (so as to not disturb the subsurface) and spray remaining vegetation <sup>1</sup> . Vegetation on the upper half of the south embankment was sprayed the week of June 24, 2019.
Exterior Slope – Concrete stairs leading to the Ohio River are damaged and unsafe. Unstable terrain	Do not use damaged stairs. Remove or repair stairs as part of the closure construction, which will also include

<p>underlies collapsing stairs.</p>	<p>regrading and stabilization of this area as necessary<sup>1</sup>.</p>
<p>Exterior Slope – Small animal burrows were observed on the top of the embankment slope.</p>	<p>Backfill with compacted soil, regrade and stabilize as necessary, or address when lowering the embankment which is planned as part of the closure construction.</p>
<p>Toe of Embankment Slope – There are several large trees and overgrown brush at the toe of slope.</p> <p>As stated previously in Table 2-2, the majority of the trees on the downstream slope of the embankment are at the toe and no seepage was observed in this area. No visual evidence was observed of stability concerns (i.e., sloughing, depressions, erosion, etc.)</p>	<p>Continue monitoring. As noted in the previous inspection report, based on the size and extent of the trees, AECOM believes removing these trees prior to the lowering of the embankment as part of the closure construction would result in significant disturbance to the unit, which could destabilize the embankment and could promote excessive erosion during high rainfall events. It is our opinion that the trees are currently necessary for stabilization of the embankment and are better left in place.</p> <p>Some of these trees might be removed for the installation of the stormwater outfall as part of the closure construction. Once the embankment is lowered as part of the closure construction, a determination will be made regarding any remaining trees.</p> <p>Monitor brush and spray/remove if it continues to encroach onto embankment slope.</p>

SLOPE APPEARS STEEPER THAN 2H:1V  
DRIFTWOOD DEBRIS AND  
DAMAGED CONCRETE STAIRS  
ON UNSTABLE GROUND

12" DIAMETER TREE ON TOE OF EMBANKMENT

4" DIAMETER TREE ON EMBANKMENT

EROSION RILLS

8" DIAMETER TREE ON EMBANKMENT

BRUSH ON EMBANKMENT

LARGE TREE AT TOE OF EMBANKMENT

VEGETATION/DEBRIS IN RIPRAP

SEVERAL LARGE TREES AT TOE OF EMBANKMENT
