January 11, 2019

CCR Annual Inspection

East Ash Pond

F. B. Culley Generating Station

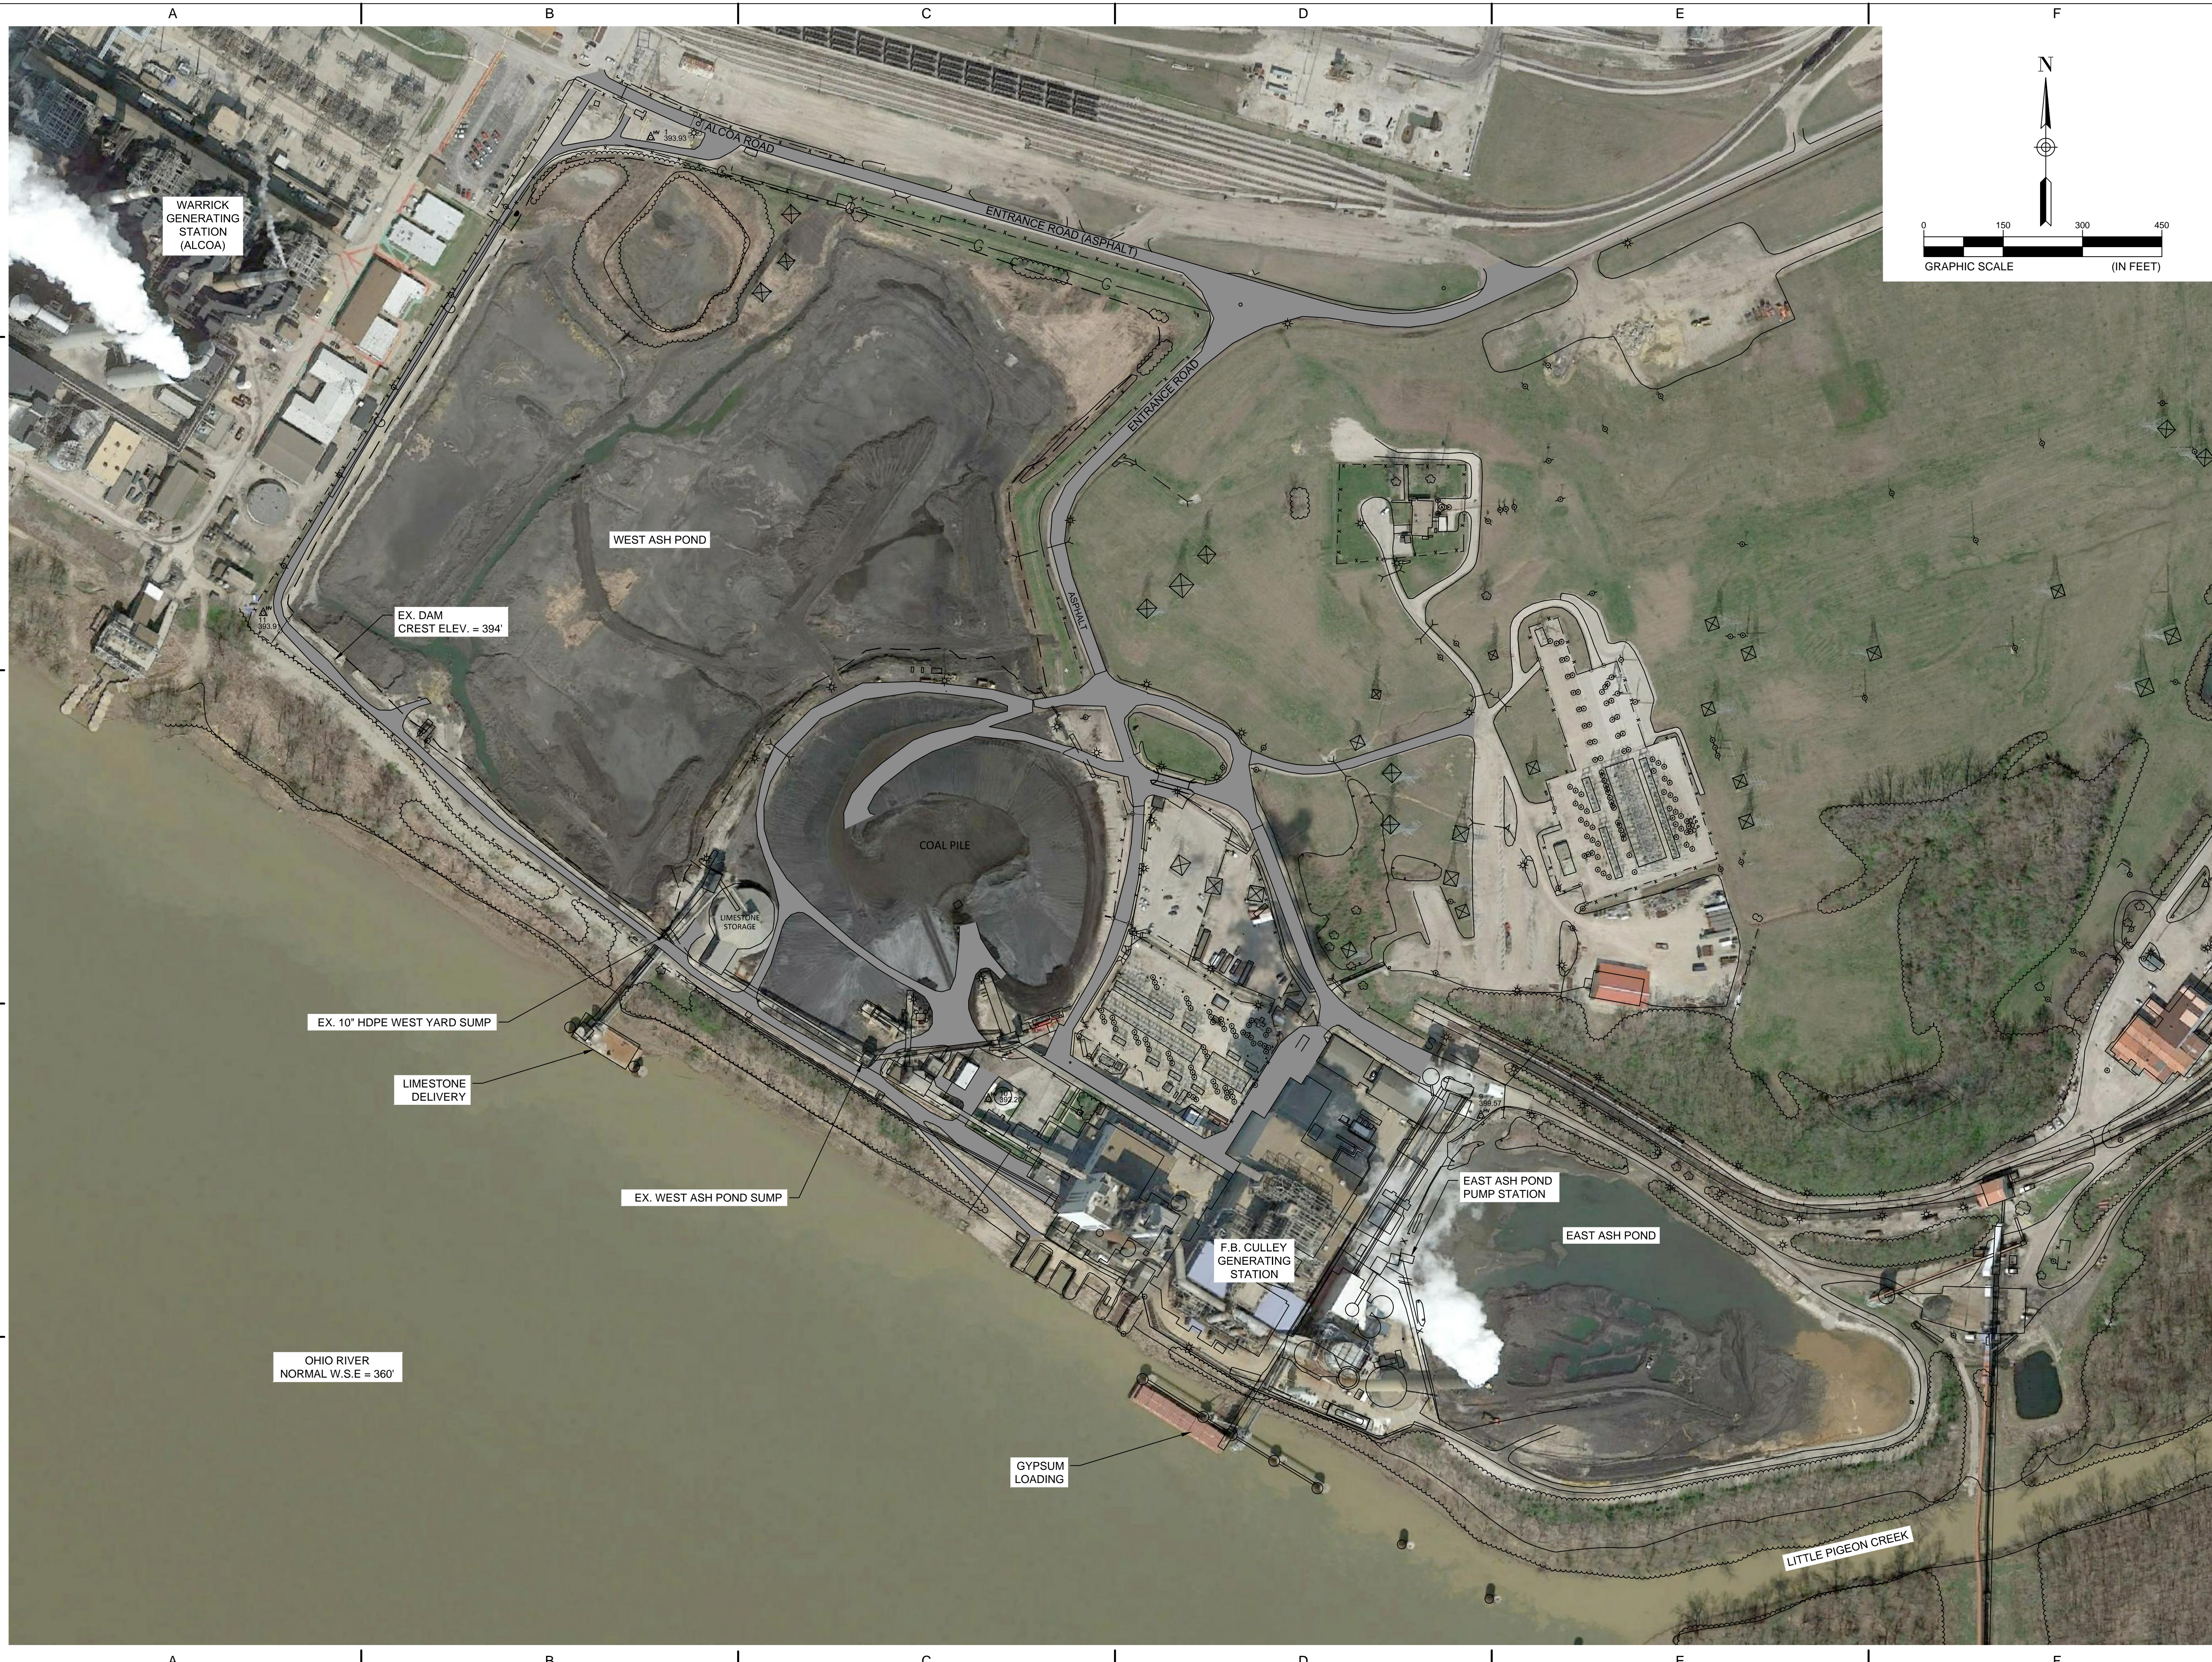
FIGURE 2

A site Location Map showing the area surrounding the station is included as **Figure 1** of **Appendix A**. **Figure 2** in **Appendix A** presents the Culley Site Map.
