VISUAL SITE INSPECTION REPORT – 2024

SOUTHERN INDIANA GAS AND ELECTRIC
A.B. BROWN GENERATING STATION
TYPE III RESTRICTED WASTE LANDFILL
WEST FRANKLIN, IN

ATLAS PROJECT NO. 170LF01692

JANUARY 2, 2025

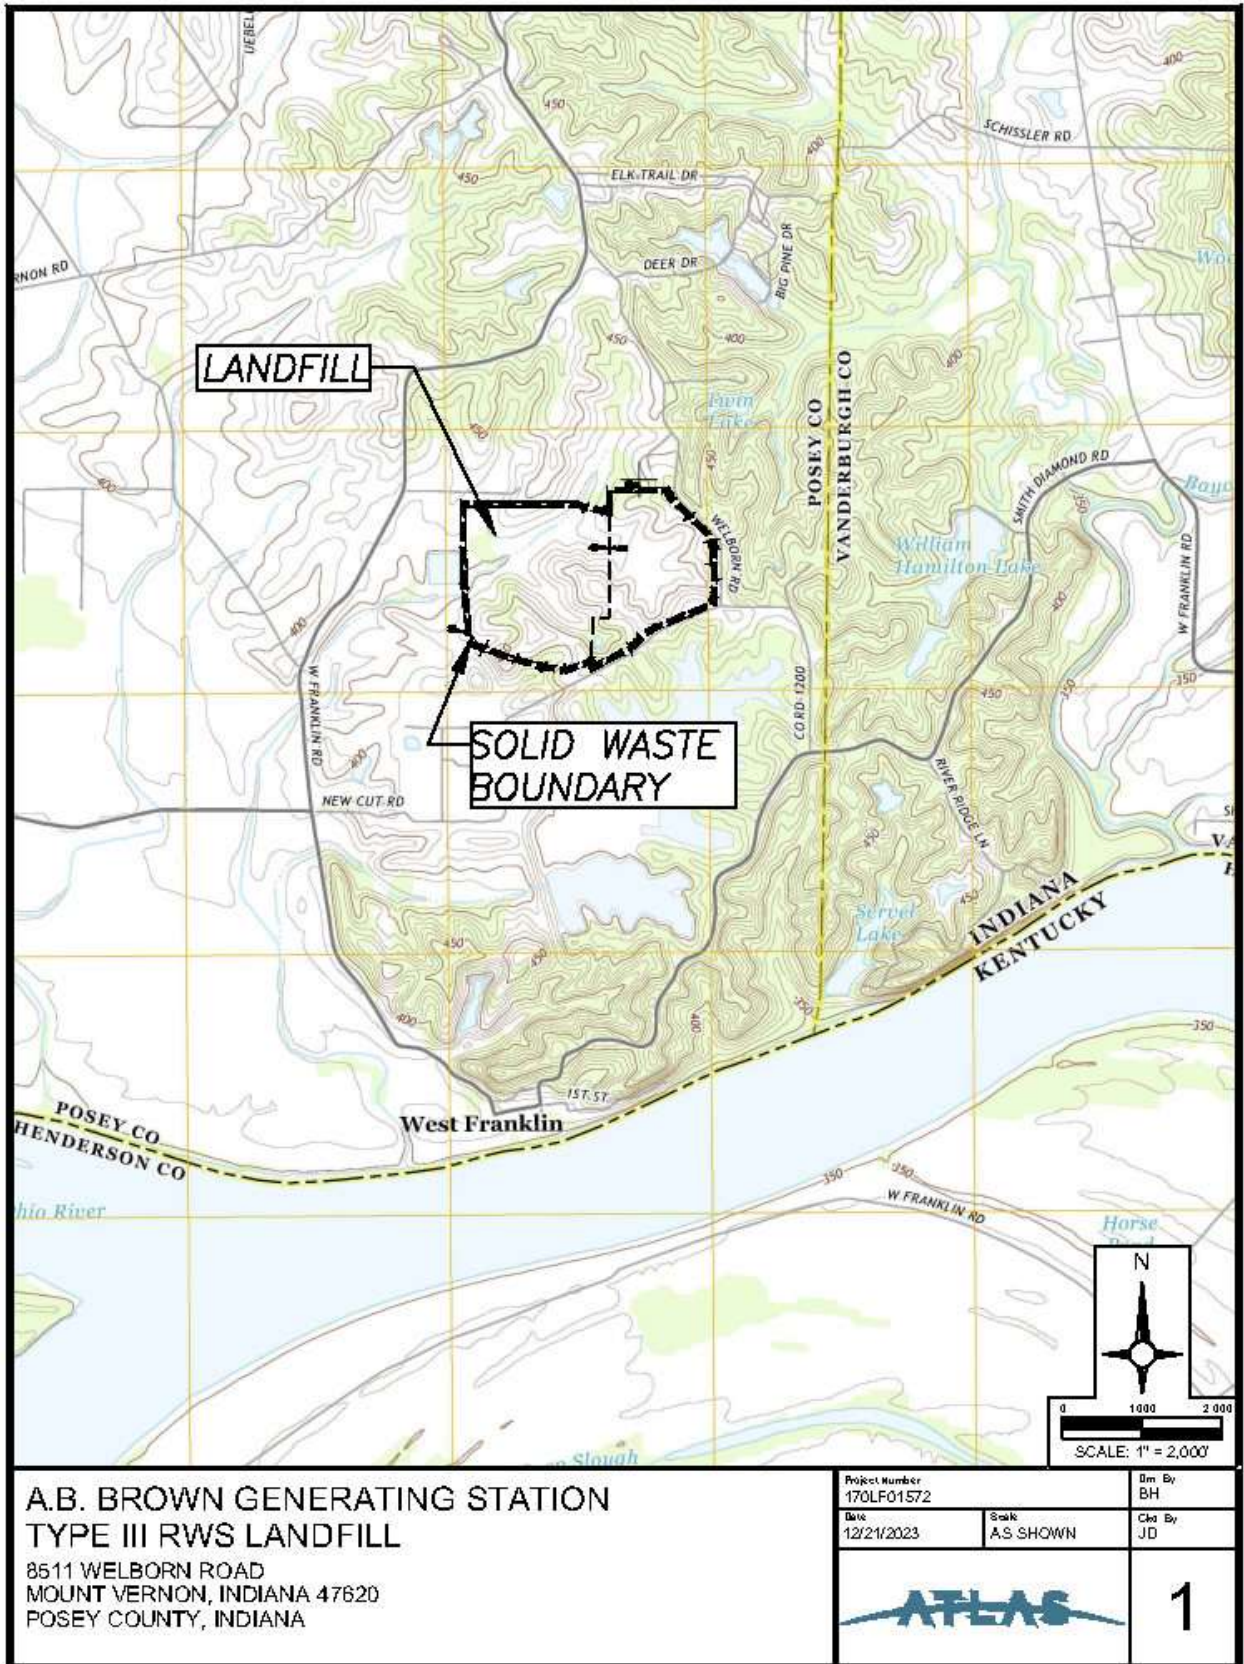
The landfill is located within the A.B. Brown Station property in Section 24, Township 7 South, and Range 12 West, about a half mile north of the Ohio River in Posey County, Indiana as highlighted on the West Franklin, IN USGS Quadrangle map, Figure 1 on the following page.
